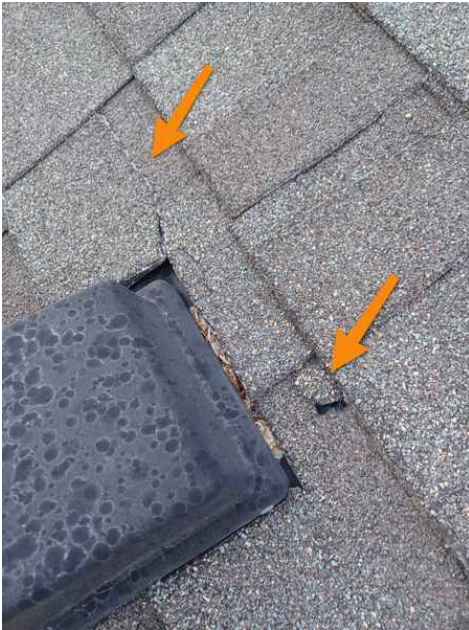
The asphalt composition shingle roof had torn or split shingles which could lead to moisture intrusion. Recommend a qualified roofing contractor repair.

Cracked shingles

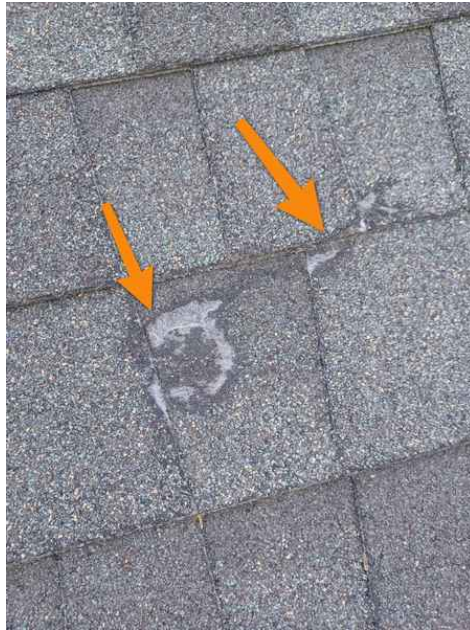
Shingle worn through. Granules and asphalt layer of shingle worn away exposing the fiberglass layer

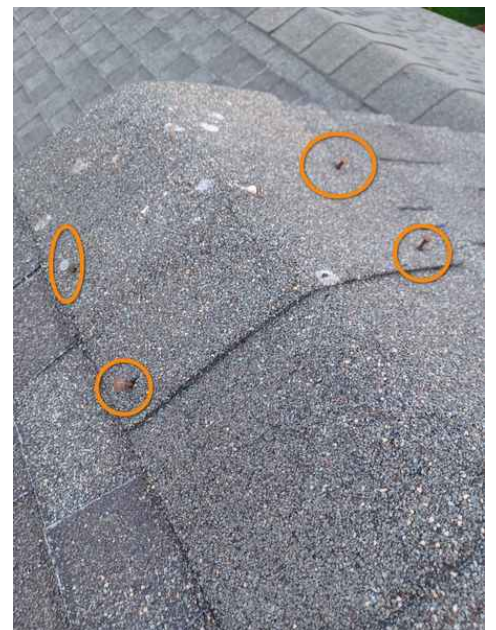
Observed one or more under-driven nails/fasteners. Recommend a qualified roofing contractor evaluate and repair.

Under driven nails on the ridge

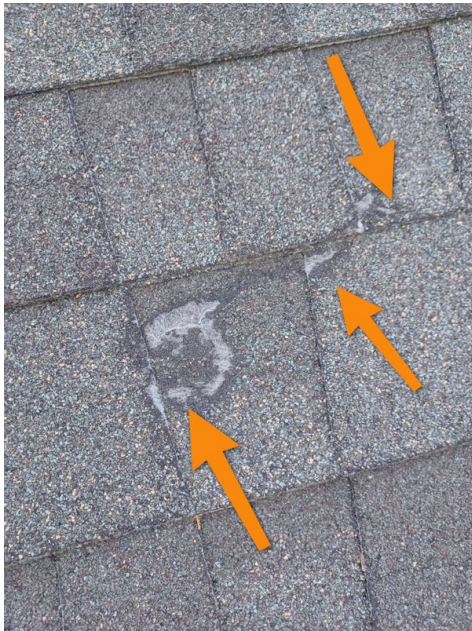
Roof has granular loss on asphalt shingles revealing fiberglass layer along edges of the shingles. A shingle along the backside of the home has worn down to the fiberglass layer. Recommend a qualified roofing contractor to evaluate.

Complete loss of granules revealing fiberglass layer

Contact a qualified roofing professional.

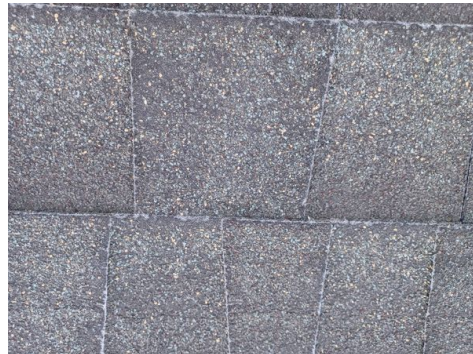
Fiberglass visible along edges of the shingles

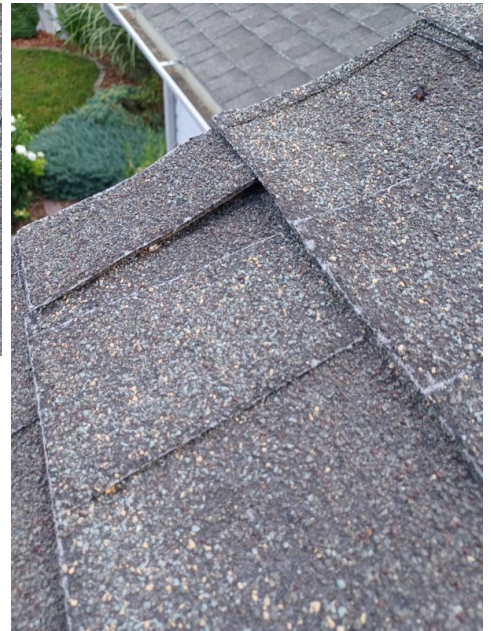
Granular loss along edges of shingles exposing fiberglass layer

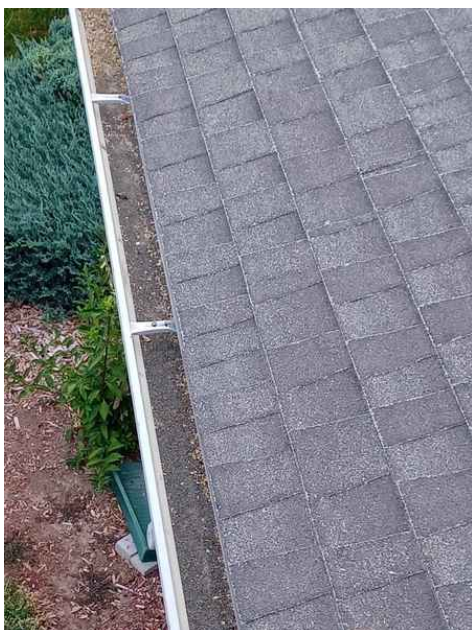
Debris has accumulated in the gutters. Recommend cleaning to facilitate water flow.

Dirt and debris accumulation in gutter

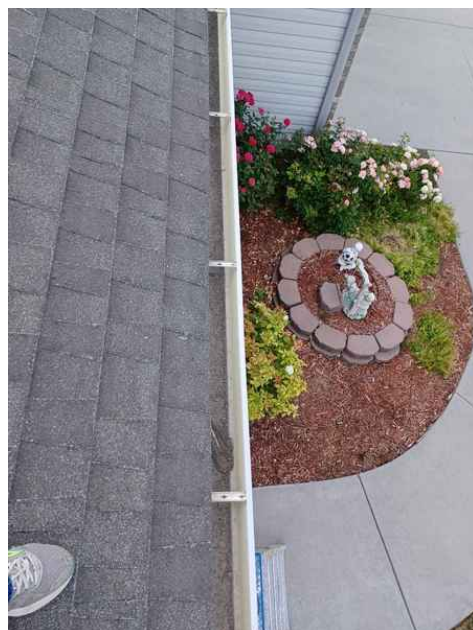
Accumulated dirt and debris in gutter

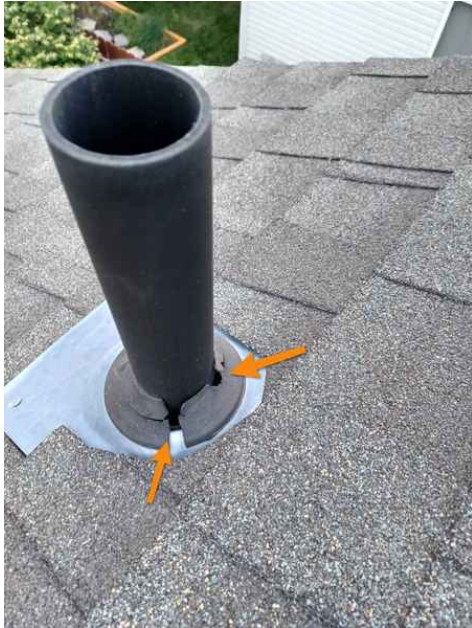
A cracked or damaged weather boot can allow moisture from snow or rain into the structure. Recommend a qualified roofing contractor to evaluate and replace.

Damaged weather boot

Contact a qualified roofing professional.

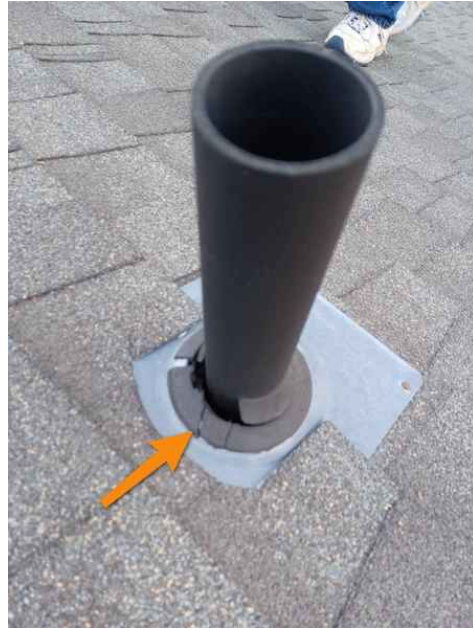
Damaged weather boot

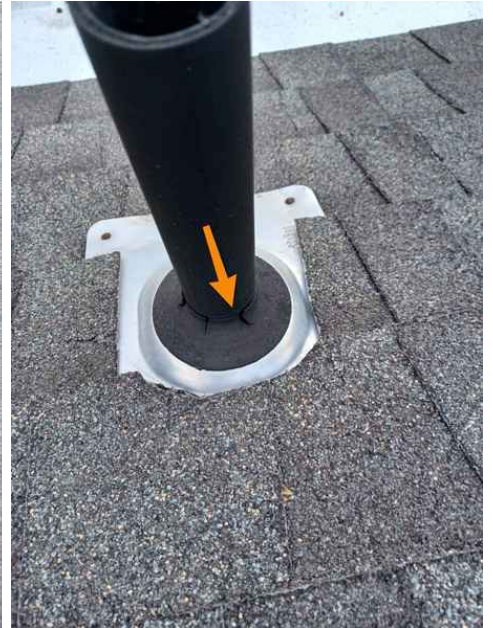
Cracked weather boot

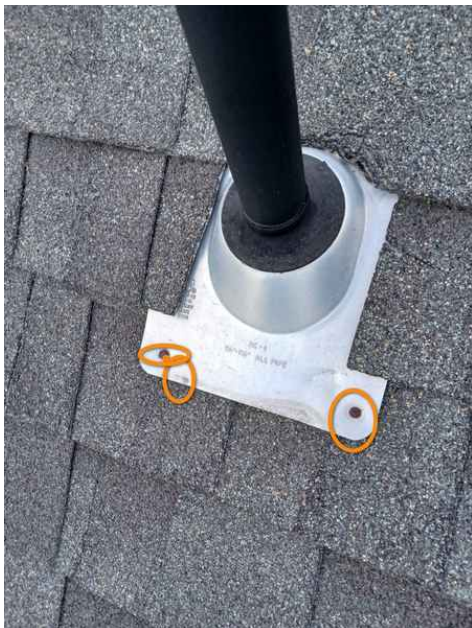
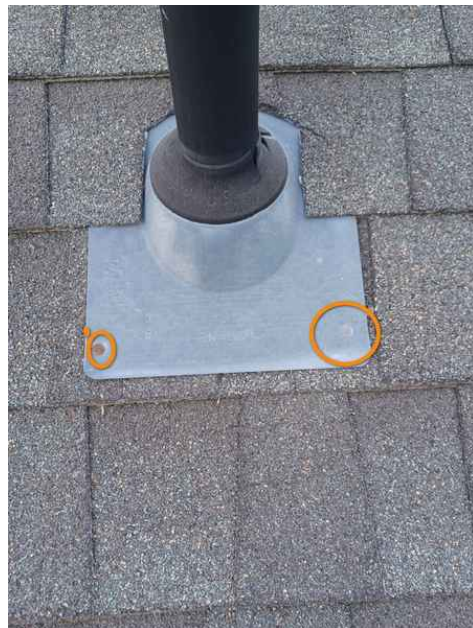
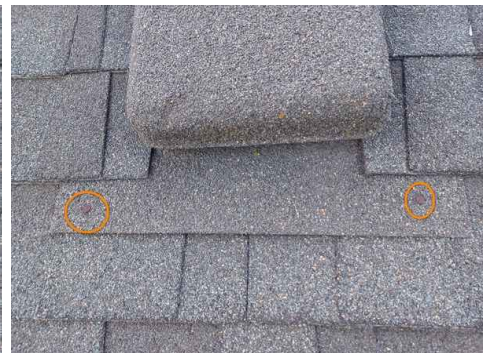
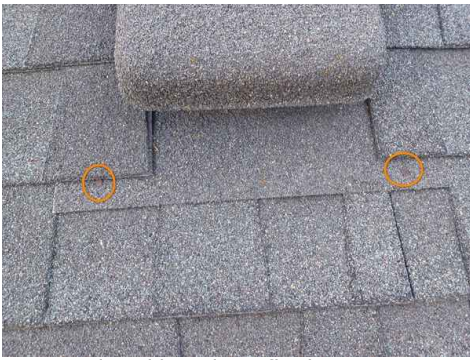
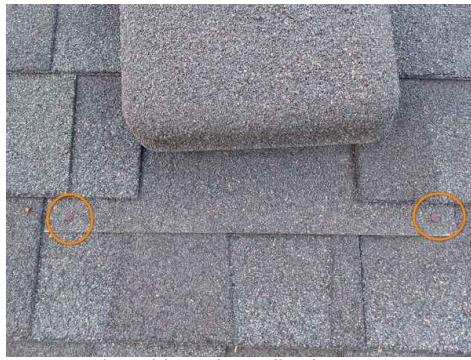
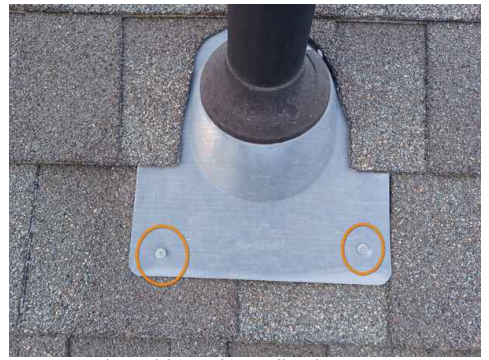
Many of the roof vents and pipes had exposed nails in the flashing. Exposed nail heads that penetrate the roof will leak in time and should always be sealed with roofing tar or caulk. Recommend a qualified roofing contractor to evaluate and repair.

Exposed nail heads in flashing

Exposed nail head in flashing

Contact a qualified roofing professional.

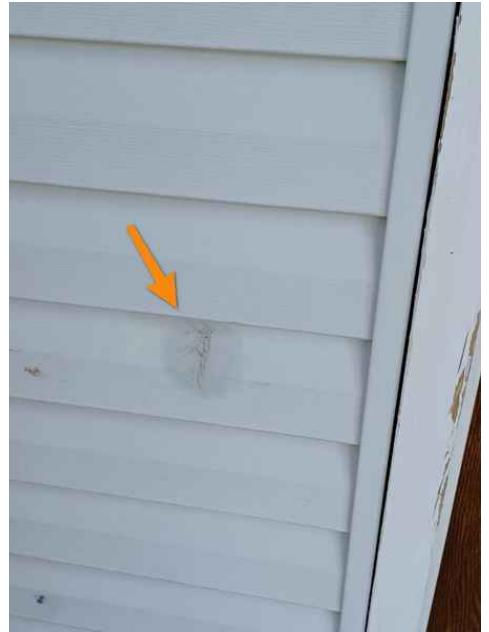
Siding has a crack at the front of the house near the front door. Recommend monitoring.

Siding crack near the front door

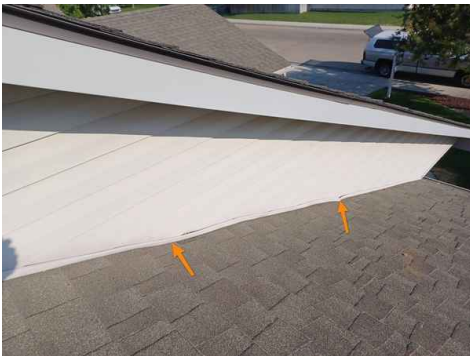
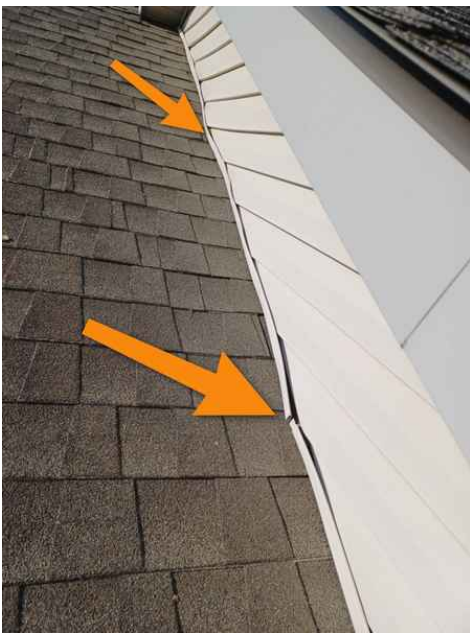
Vinyl siding was warping where the siding faces the front of the west roof above the front bedroom. The siding trim was also separated. This is often as a result of nailing siding boards too tight to the home, preventing expansion/contraction. Recommend a qualified siding contractor evaluate and repair.

Warped siding and trim piece. Trim piece has separated.

Warped siding and separated trim piece

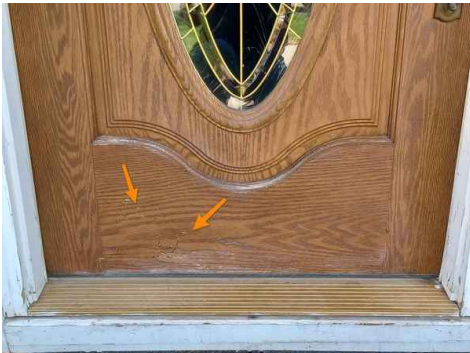
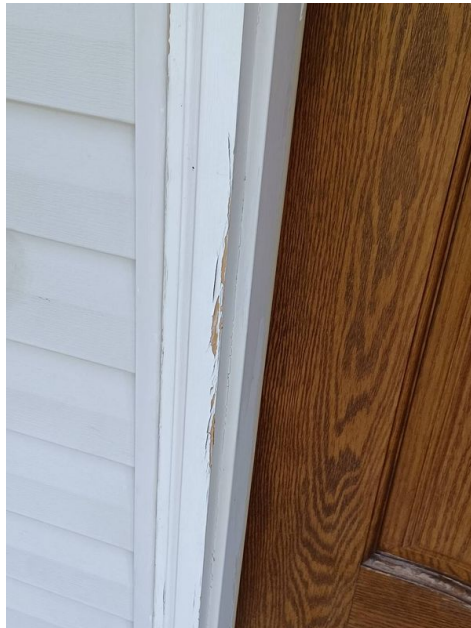
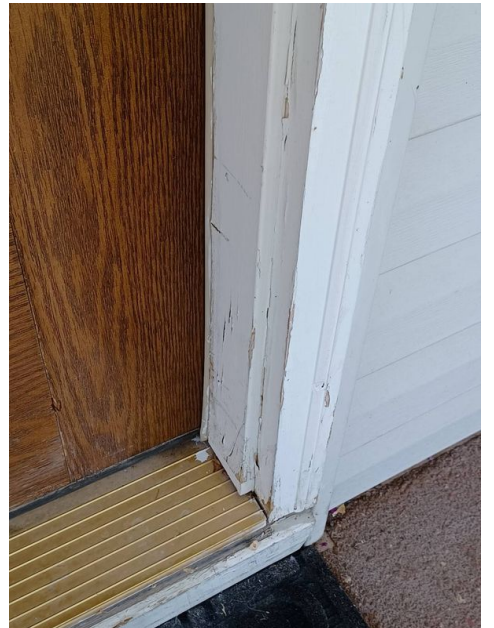
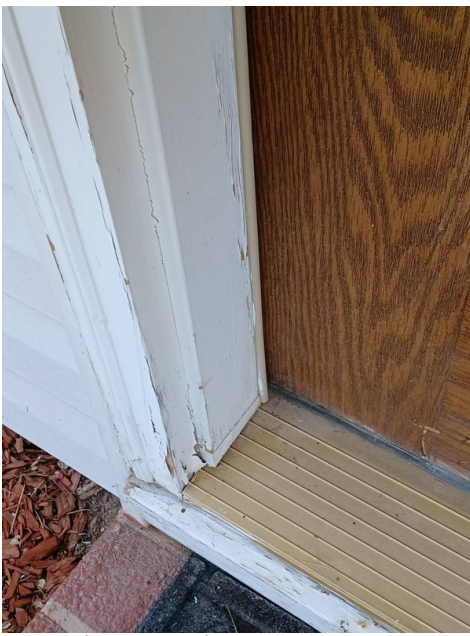
Door sill and/or trim on front door and door from garage to backyard is deteriorated or worn and repair or replacement should be considered.

Front door damage at the bottom

Front door trim damage

Front door room damage

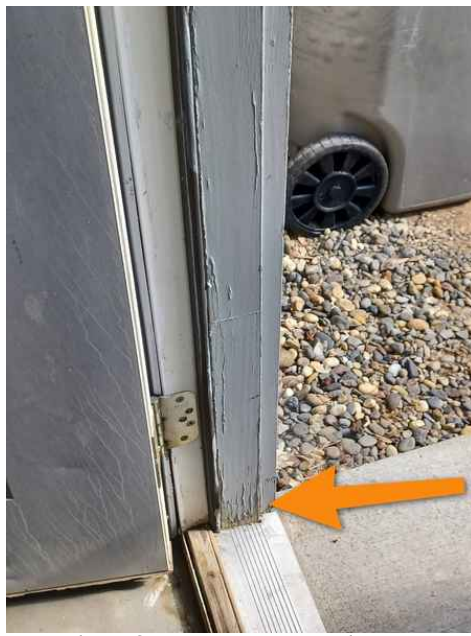
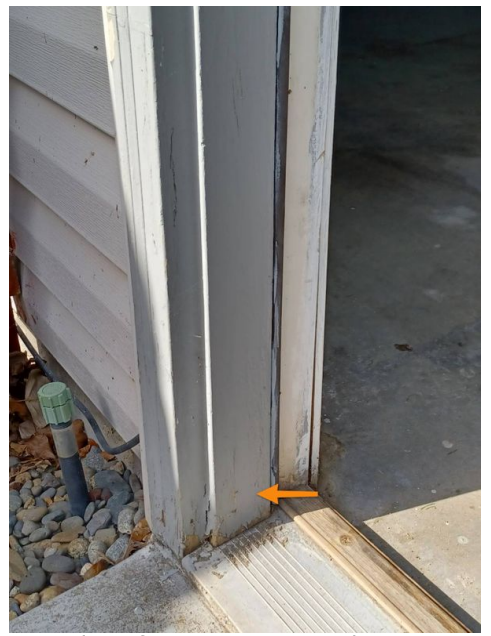
Man-door from garage trim damage

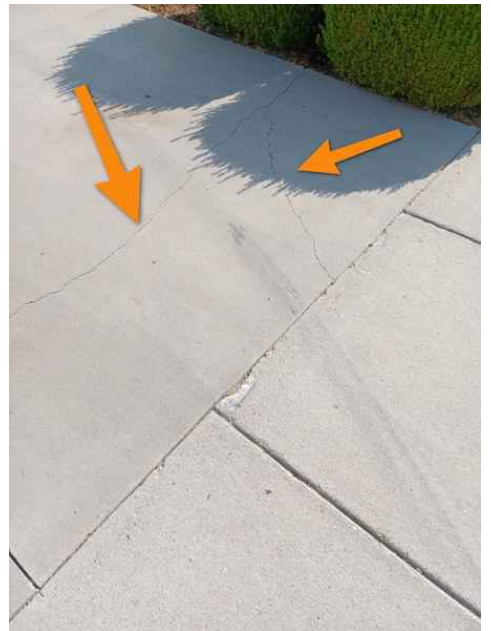
Minor cosmetic cracks observed, which may indicate movement in the soil. Recommend monitor and/or have concrete contractor patch/seal.

Cracks on the driveway

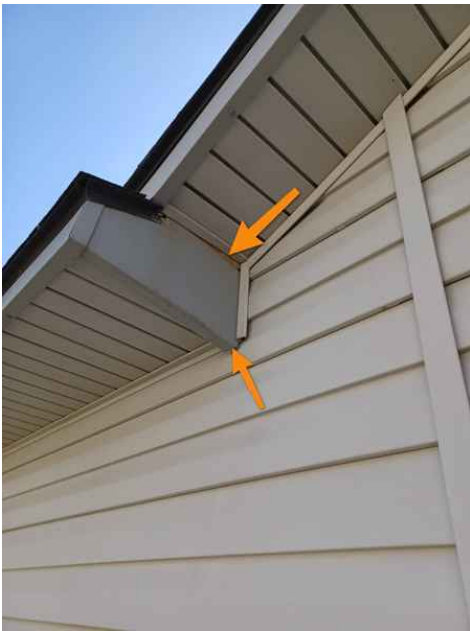
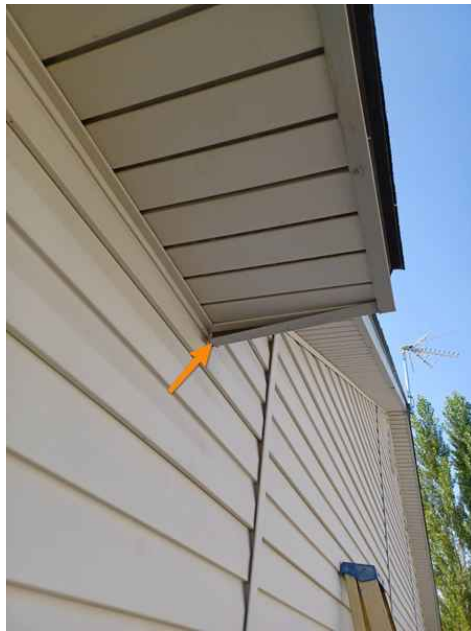
There is a gap in the fascia / soffit where the fascia trim has come loose and fallen. This can allow water intrusion and rodent infestation as well as deterioration of the surrounding material.

Fascia has slipped down

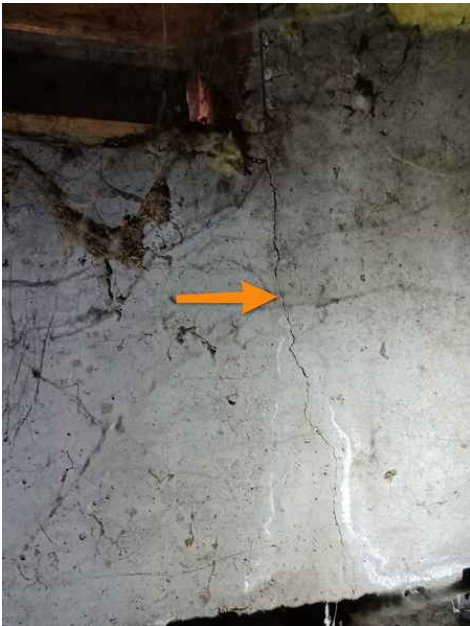
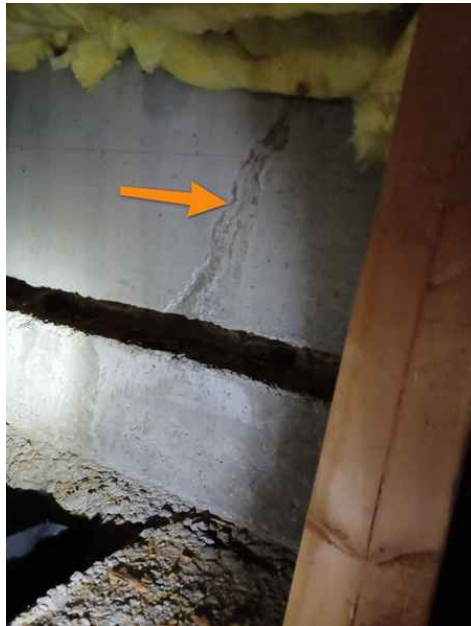
Minor cracking was noted at the foundation. This is common as concrete ages and shrinkage surface cracks are normal. Recommend monitoring for more serious shifting/displacement.

Small crack at west side of home's foundation

Small crack at west side of foundation wall

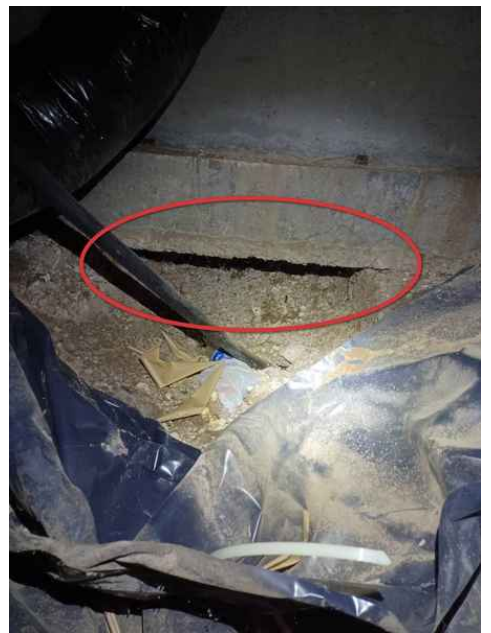
Foundation has been dug out where water main enters under the house. The concrete foundation has a section where approximately 3 feet are unsupported. Recommend evaluation by a qualified contractor or engineer for evaluation.

Approximately 3 feet of the concrete foundation has been dug out and left unsupported

Contact a qualified professional.

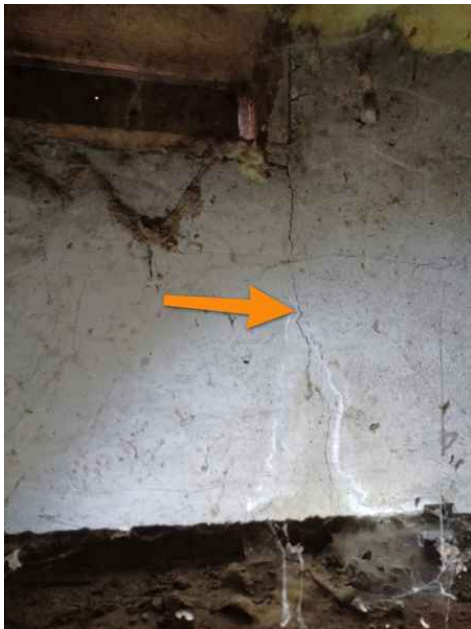
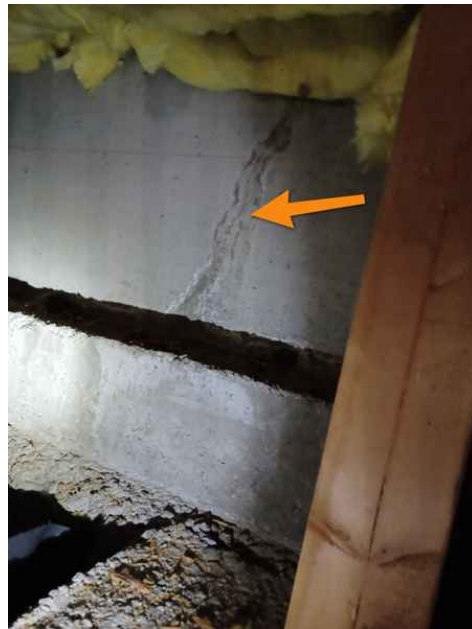
Efflorescence noted on the crawlspace surface. This is a white, powdery deposit that is consistent with moisture intrusion. This can compromise the soil's ability to support the home structure and/or lead to mold growth. Recommend a qualified contractor identify source or moisture and correct.

Efflorescence at small crack in the concrete foundation

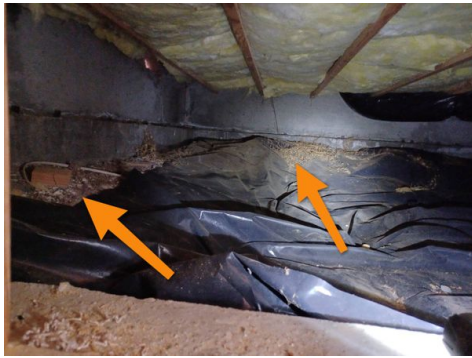
Trash, construction debris and dead vegetation are present in the crawlspace. Recommend removal as these items can attract pests.

Dead vegetation and trash

Recommendation
Contact a qualified professional.

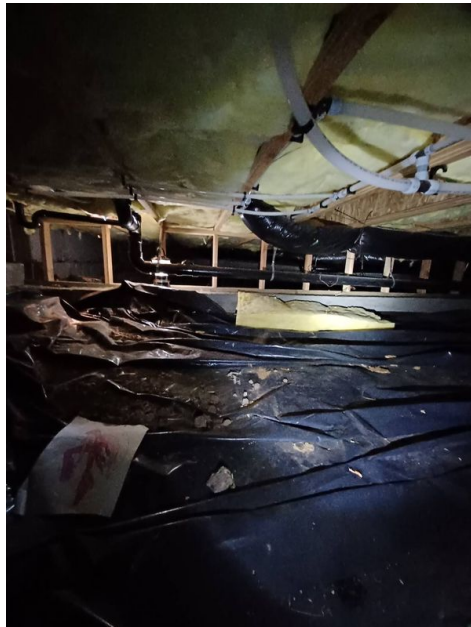
Trash

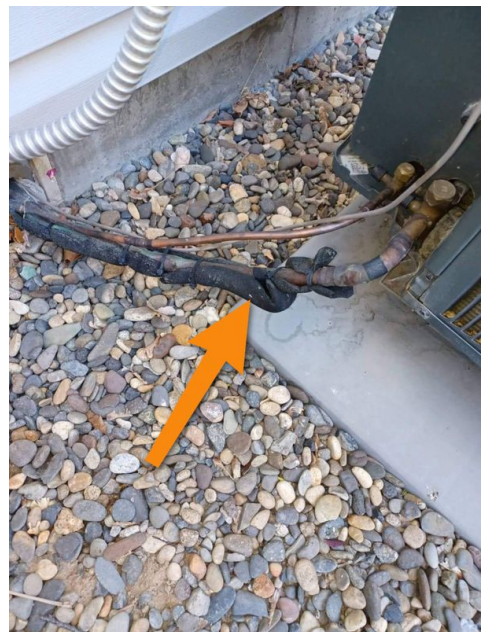
Missing or damaged insulation on refrigerant line can cause energy loss and condensation.

Incomplete insulation on refrigerant lines

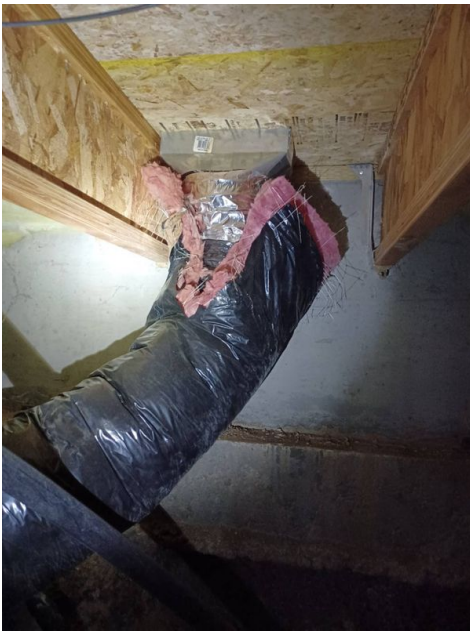
Parts of the ductwork are uninsulated, resulting in energy loss. Recommend licensed HVAC contractor insulate.

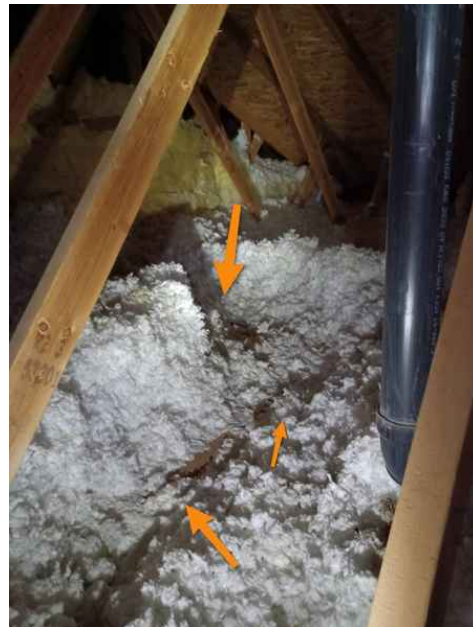
There are areas in the attic where insulation depth was inadequate. Recommend a qualified attic insulation contractor install additional insulation.

Insulation has settled or been moved in areas of the attic.

Contact a qualified insulation contractor.

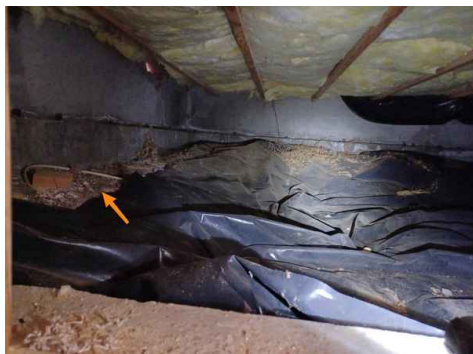
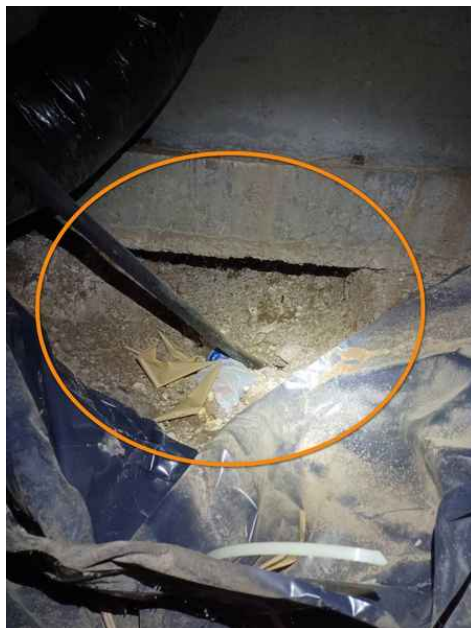
Vapor barrier is improperly installed. The vapor barrier is not fastened which has resulted in portions of the dirt in the crawlspace to be exposed. This can result in unwanted moisture. Recommend insulation contractor evaluate.

Exposed dirt

Vapor retarder pulled back exposing dirt

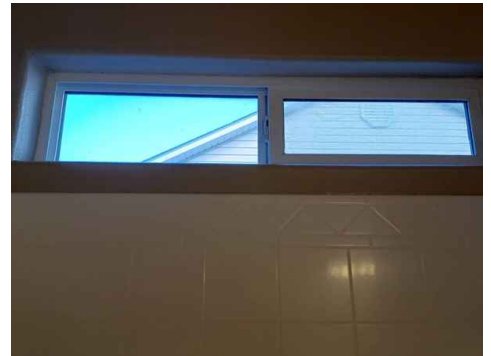
Observed small amount of condensation between the window panes in the master bathroom, master bedroom, bathroom 2, back bedroom, and kitchen which indicates a failed seal. Recommend qualified window contractor evaluate & replace.

bathroom 2 window

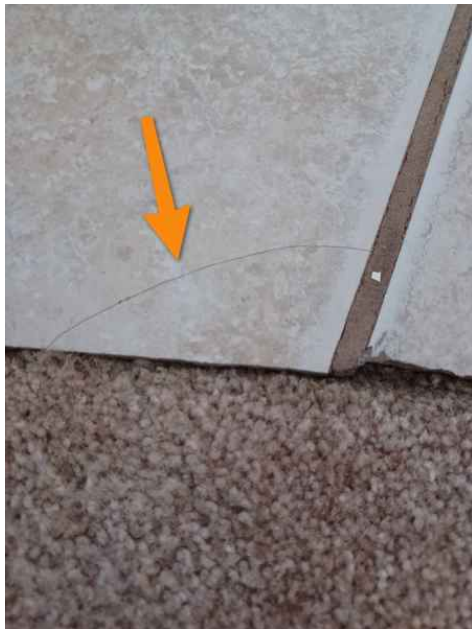
Observed hairline crack at entry to master bathroom along with some chipping of tile near vanity cabinet. Chip at refrigerator space.

Entry to master bathroom crack in the tile

Contact a qualified professional.

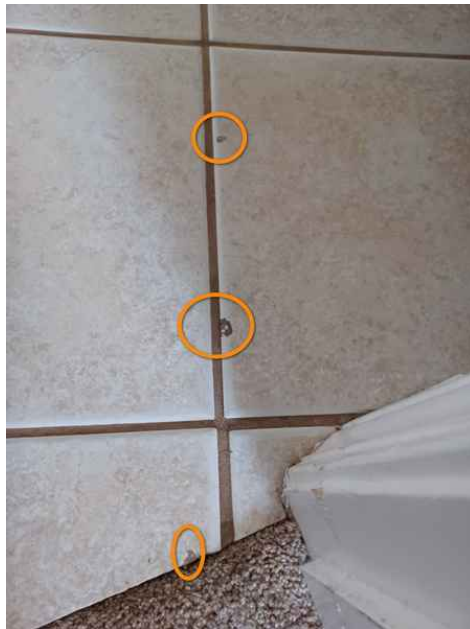
chips in the tile in the master bathroom

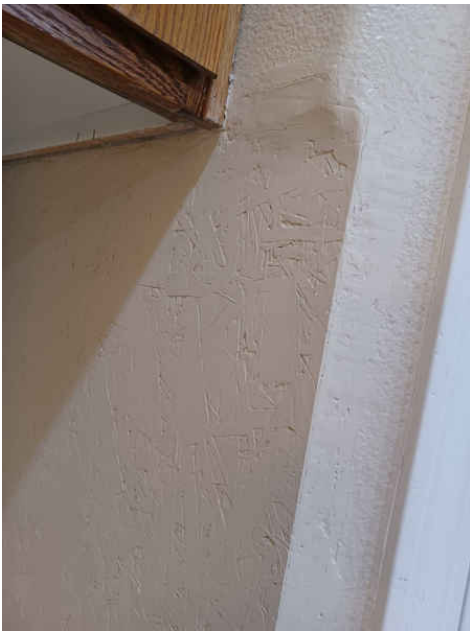
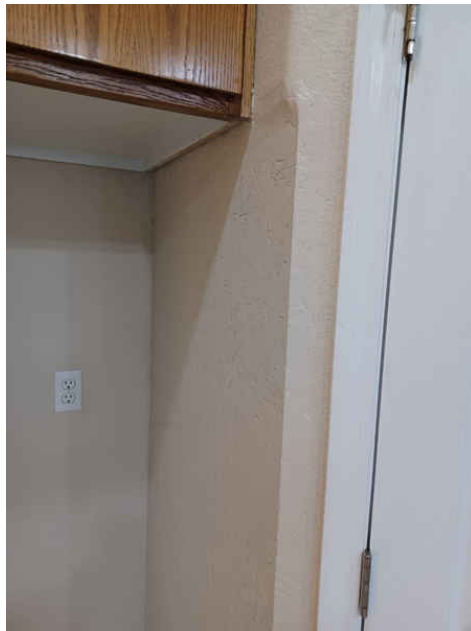
Drywall has been removed at right side of refrigerator space and painted OSB board installed.

Drywall removed and OSB installed

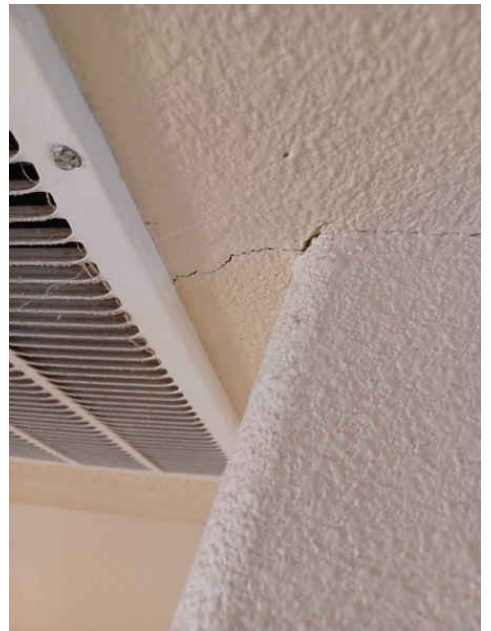
Minor damage to the ceiling was visible at the time of the inspection. Crack on the ceiling at the forced air return.

Crack in the drywall at the forced air return

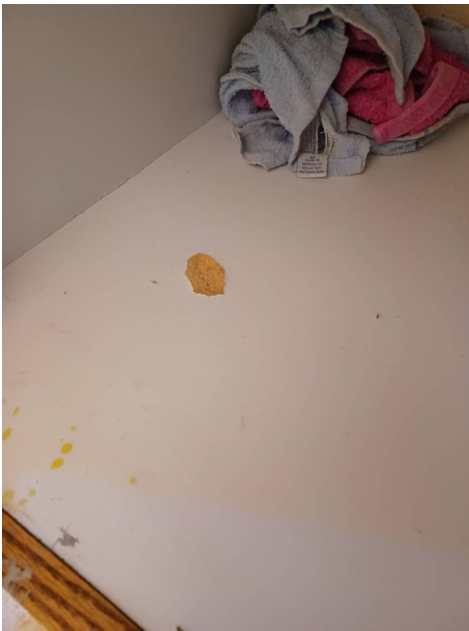
Cabinets had visible damage at time of inspection.

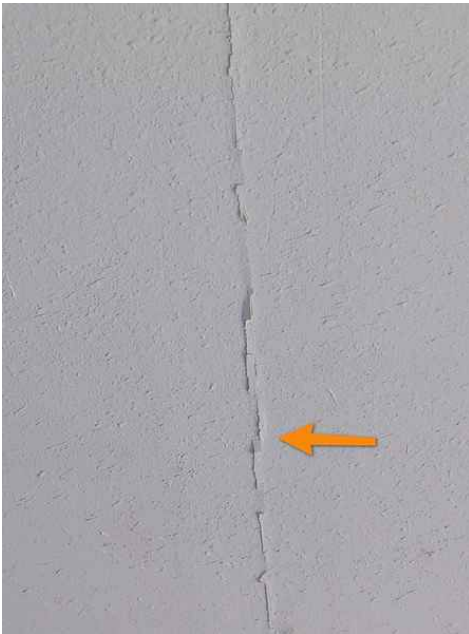
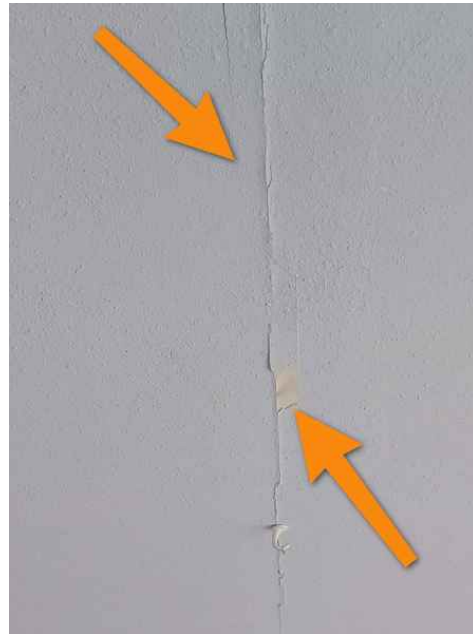
Drywall tape along a joint in the ceiling of the garage is separating from the drywall. Recommend qualified contractor evaluate and repair.

Drywall tape separating from drywall joint in ceiling

Drywall tape separating from drywall at drywall joint in ceiling

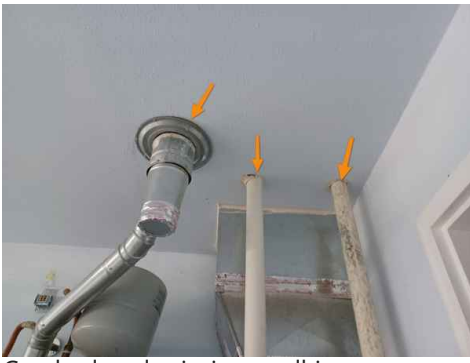
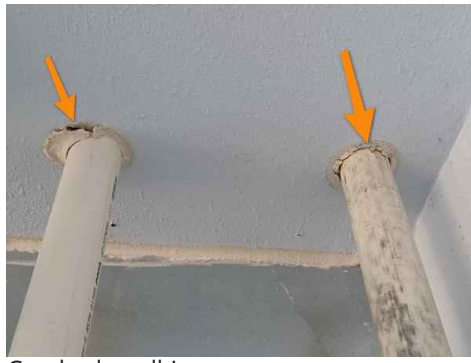
There are 3 ceiling penetrations that pass through into the attic. The two pipes that originate from the furnace unit have caulking that is cracked and the exhaust pipe from the water heater did not have caulking.

Cracked and missing caulking

Cracked caulking

Recommendation
Contact a qualified professional.
