## RESIDENTIAL REPORT

1124 W Aberdeen Ave  
Nampa, ID 83686

Ruth Woodford  
AUGUST 4, 2022

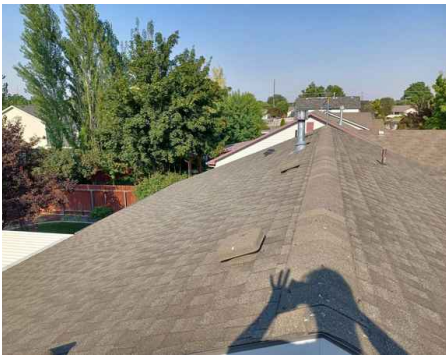
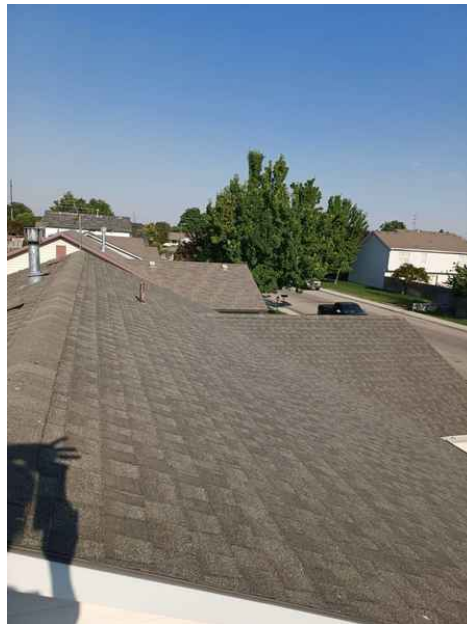
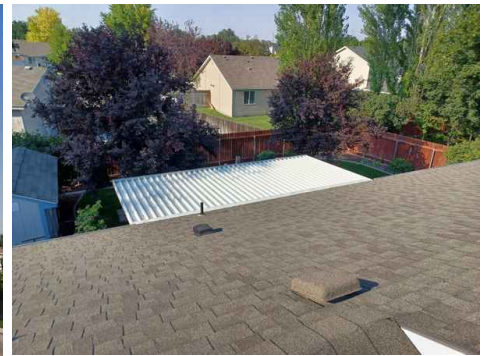
Asphalt

This roof is covered with asphalt architectural shingles.

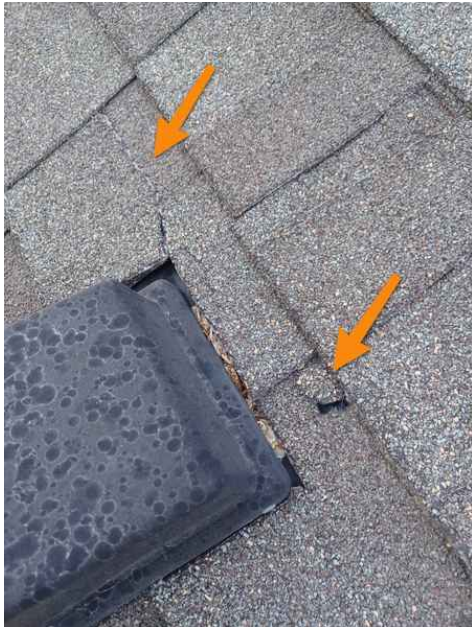
The asphalt composition shingle roof had torn or split shingles which could lead to moisture intrusion. Recommend a qualified roofing contractor repair.

Cracked shingles

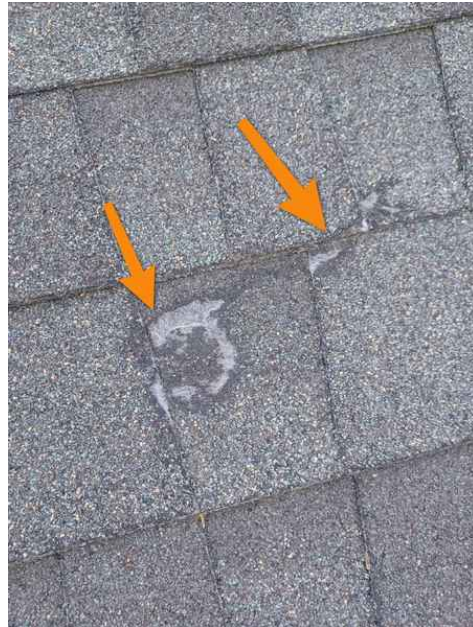
Shingle worn through. Granules and asphalt layer of shingle worn away exposing the fiberglass layer

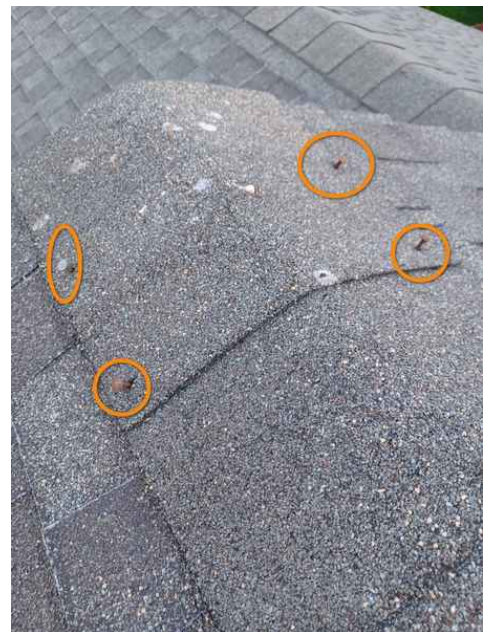
Observed one or more under-driven nails/fasteners. Recommend a qualified roofing contractor evaluate and repair.

Under driven nails on the ridge

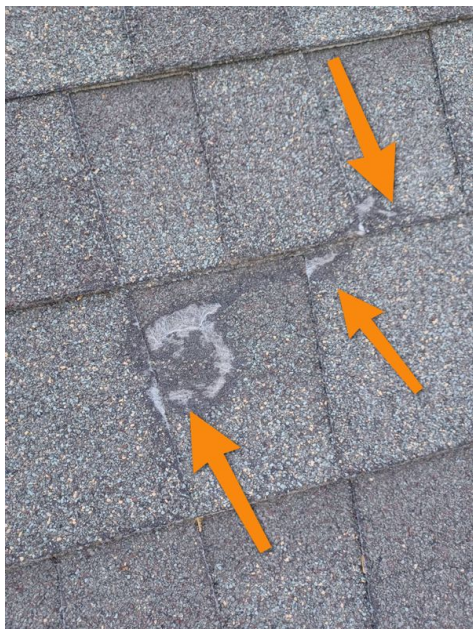
Roof has granular loss on asphalt shingles revealing fiberglass layer along edges of the shingles. A shingle along the backside of the home has worn down to the fiberglass layer. Recommend a qualified roofing contractor to evaluate.

Complete loss of granules revealing fiberglass layer

Contact a qualified roofing professional.

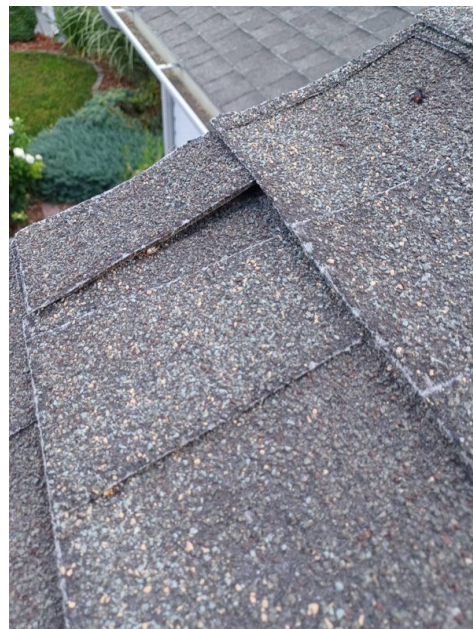
Granular loss along edges of shingles exposing fiberglass layer

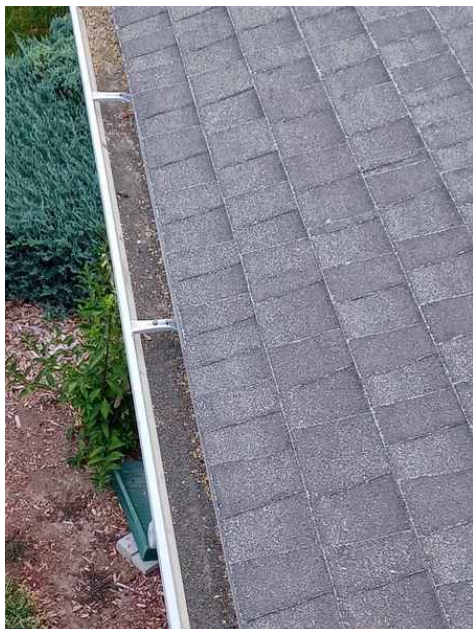
Debris has accumulated in the gutters. Recommend cleaning to facilitate water flow.

Dirt and debris accumulation in gutter

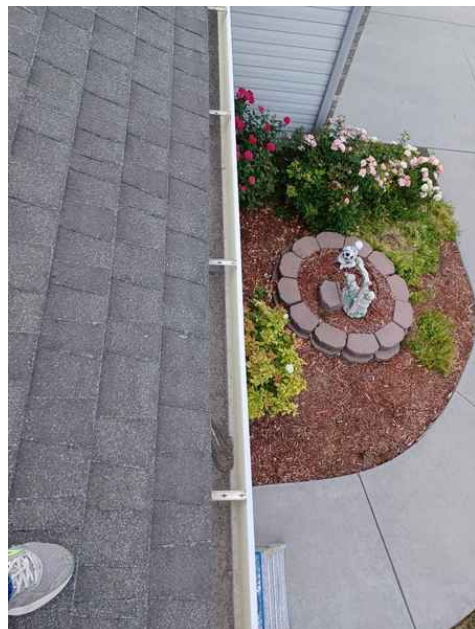
Accumulated dirt and debris in gutter

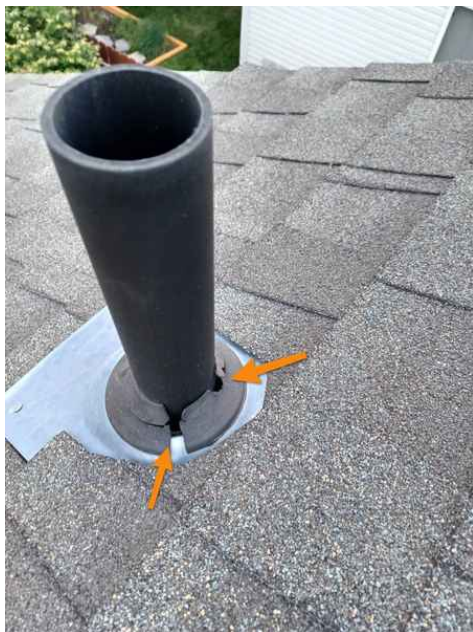
A cracked or damaged weather boot can allow moisture from snow or rain into the structure. Recommend a qualified roofing contractor to evaluate and replace.

Damaged weather boot

Contact a qualified roofing professional.

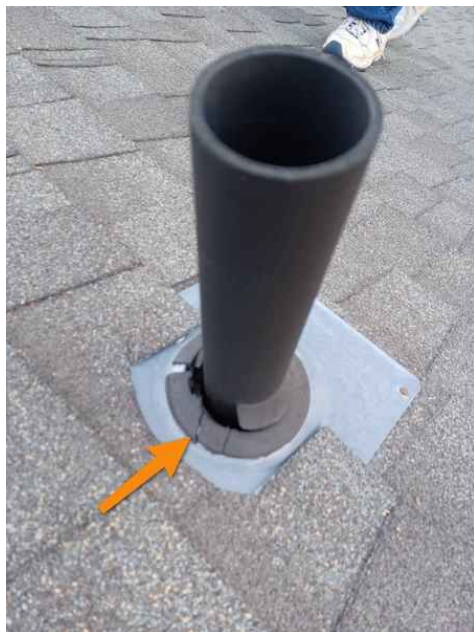
Damaged weather boot

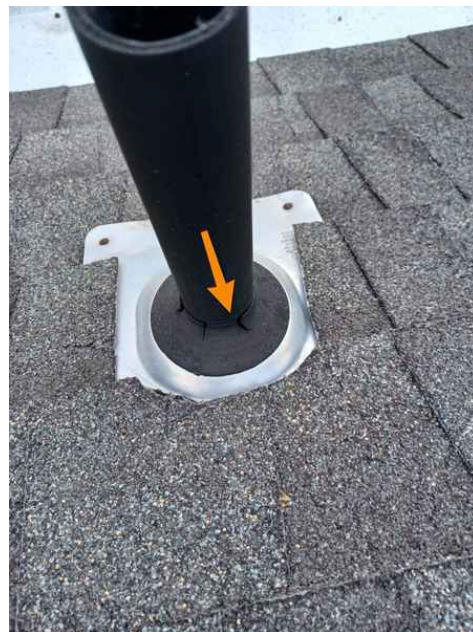
Cracked weather boot

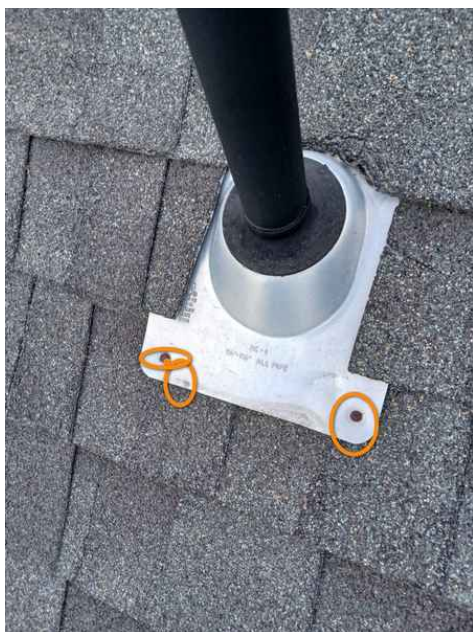
Many of the roof vents and pipes had exposed nails in the flashing. Exposed nail heads that penetrate the roof will leak in time and should always be sealed with roofing tar or caulk. Recommend a qualified roofing contractor to evaluate and repair.

Exposed nail heads in flashing

Contact a qualified roofing professional.

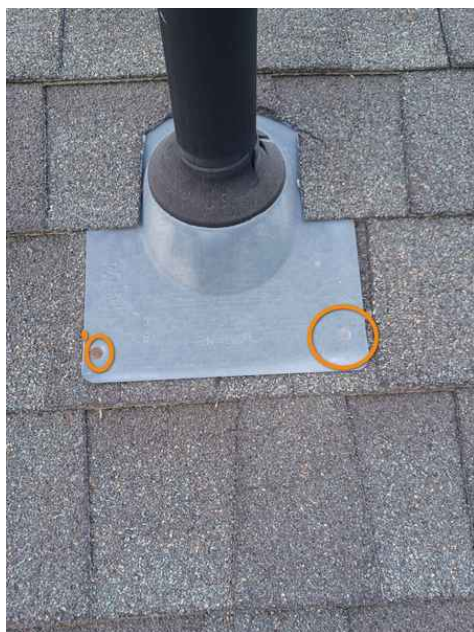
Exposed nail head in flashing

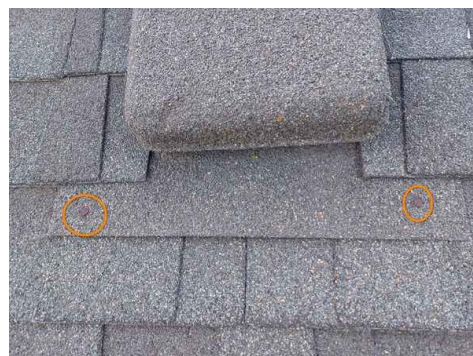
Exposed nail heads in flashing

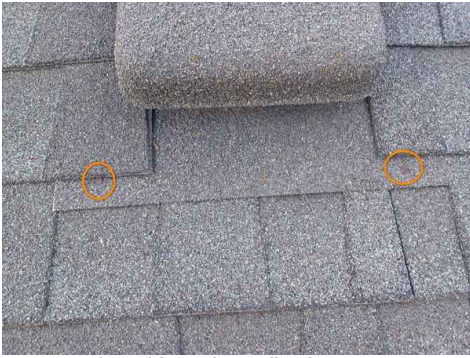
Exposed nail heads in flashing

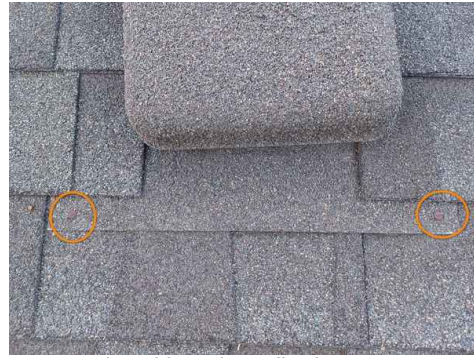
Exposed nail heads in flashing

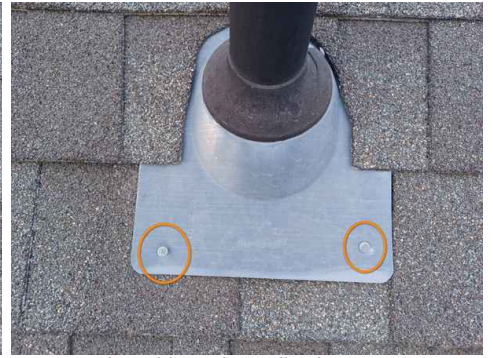
Exposed nail heads in flashing

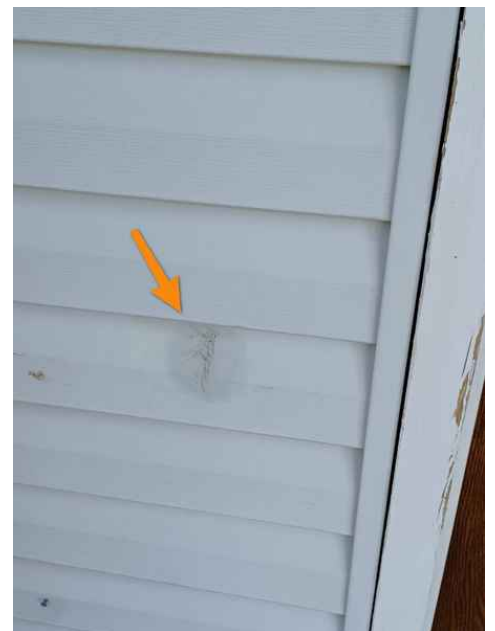
Siding has a crack at the front of the house near the front door. Recommend monitoring.

Siding crack near the front door

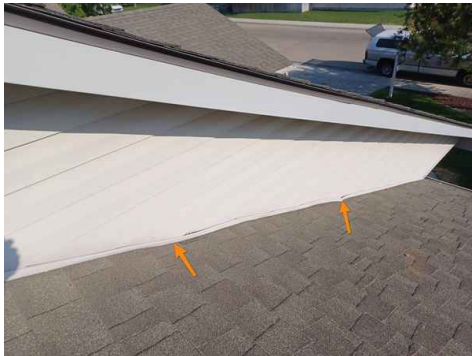
Vinyl siding was warping where the siding faces the front of the west roof above the front bedroom. The siding trim was also separated. This is often as a result of nailing siding boards to tight to the home, preventing expansion/contraction. Recommend a qualified siding contractor evaluate and repair.

Warped siding and trim piece. Trim piece has separated.

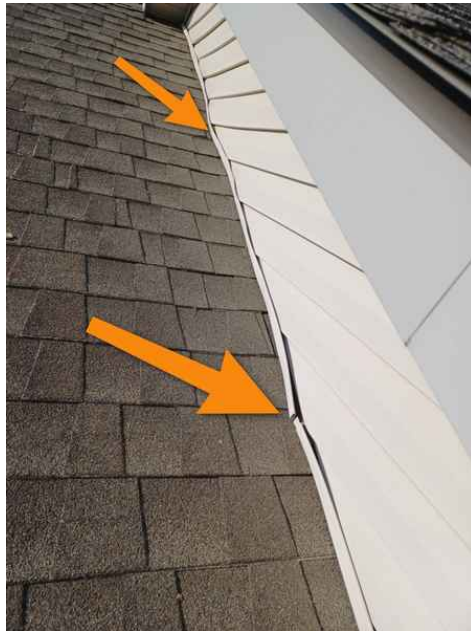
Warped siding and separated trim piece

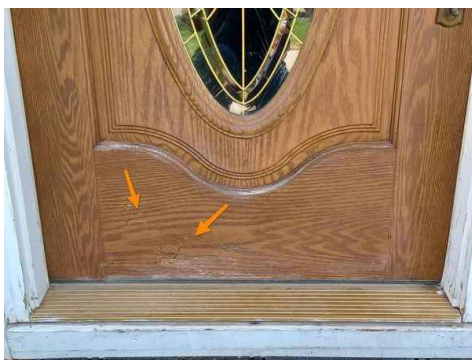
Door sill and/or trim on front door and door from garage to backyard is deteriorated or worn and repair or replacement should be considered.

Front door damage at the bottom

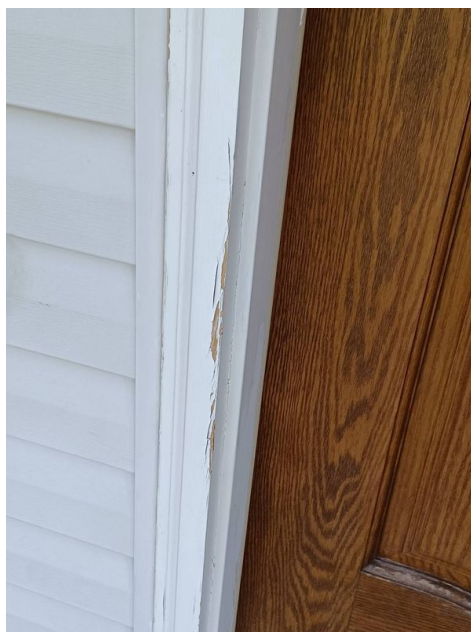
Front door trim damage

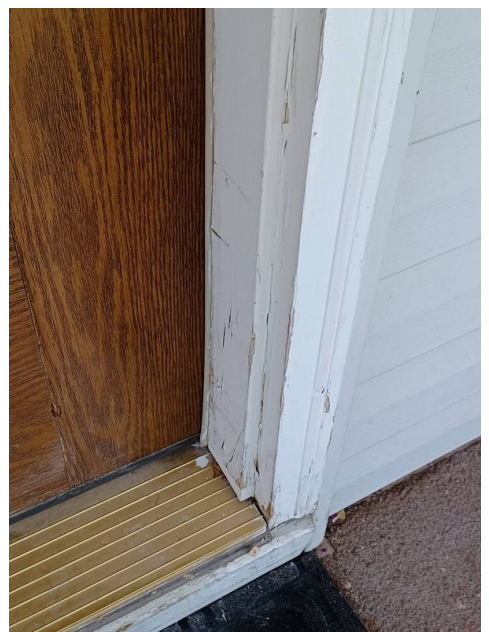
Front door room damage

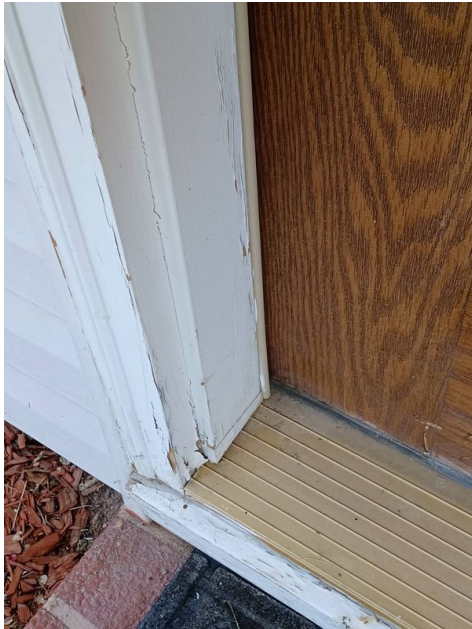
Front door trim damage

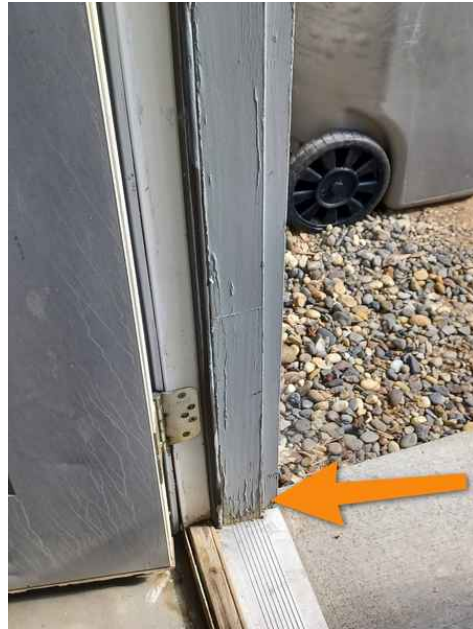
Man-door from garage trim damage

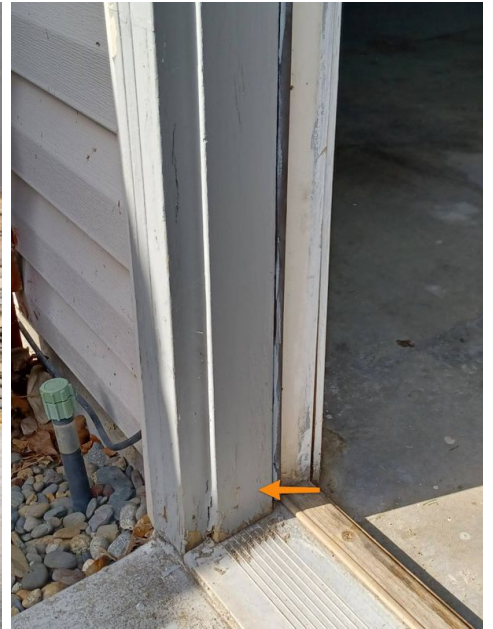
Man-door from garage trim damage

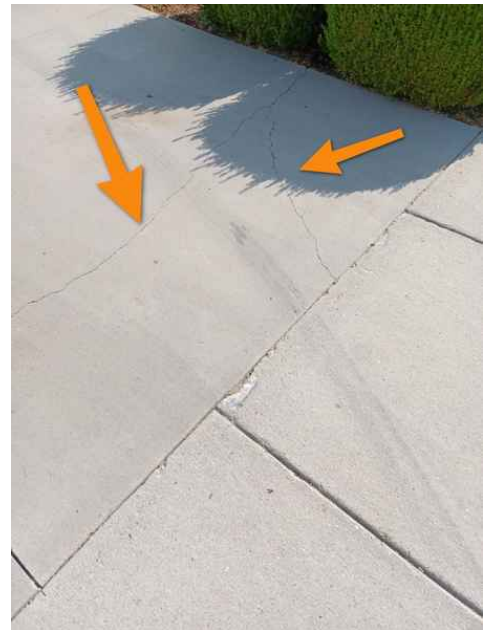
Minor cosmetic cracks observed, which may indicate movement in the soil. Recommend monitor and/or have concrete contractor patch/seal.

Cracks on the driveway

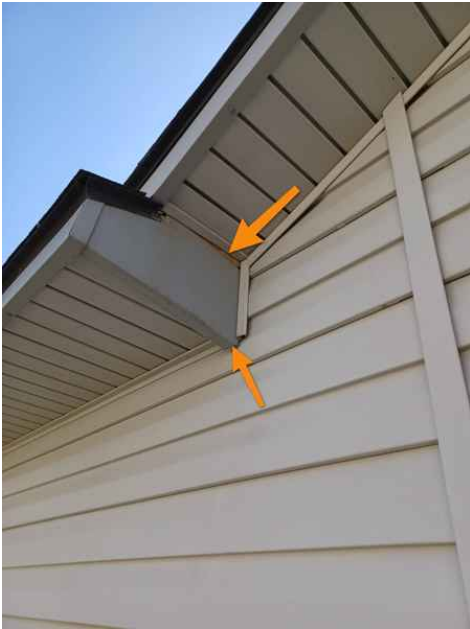
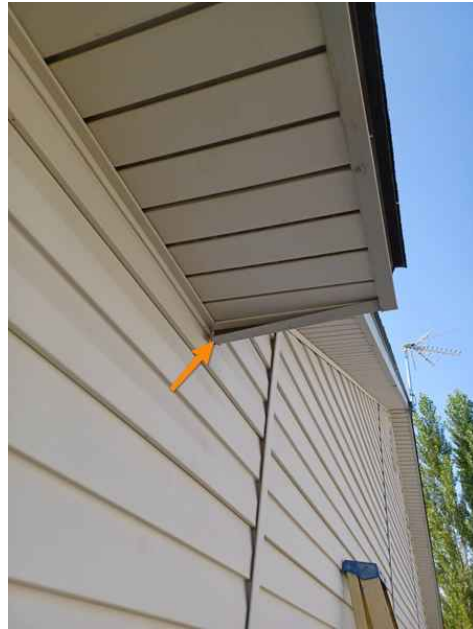
There is a gap in the fascia / soffit where the fascia trim has come loose and fallen. This can allow water intrusion and rodent infestation as well as deterioration of the surrounding material.

Fascia has slipped down

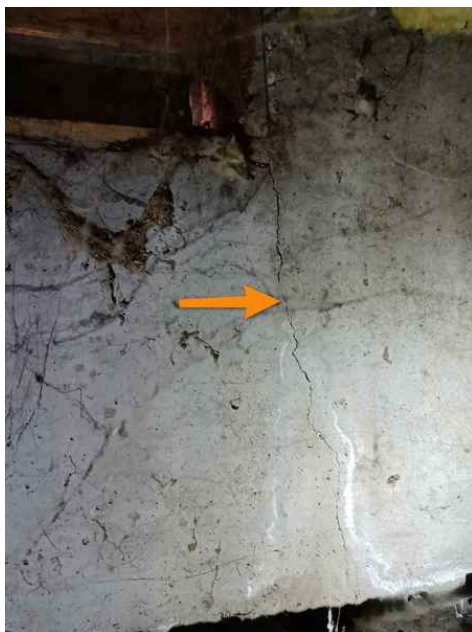
Minor cracking was noted at the foundation. This is common as concrete ages and shrinkage surface cracks are normal. Recommend monitoring for more serious shifting/displacement.

Small crack at west side of home's foundation

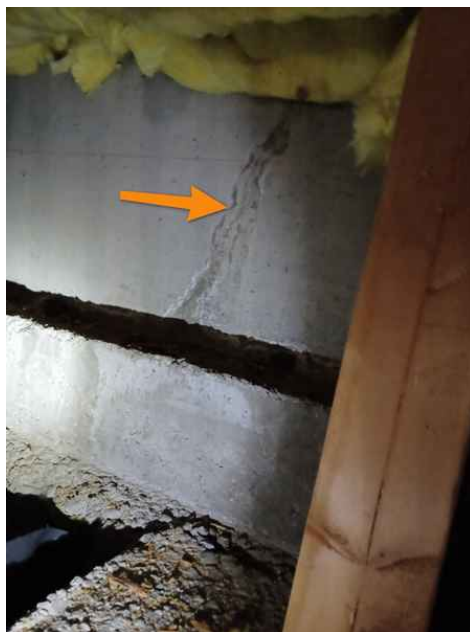
Small crack at west side of foundation wall

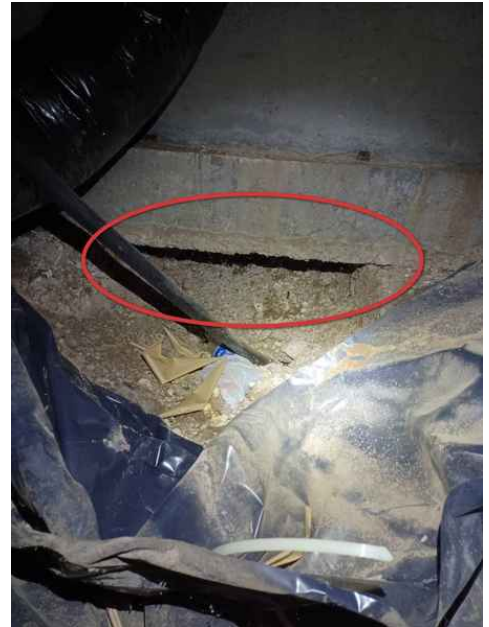
Foundation has been dug out where water main enters under the house. The concrete foundation has a section where approximately 3 feet are unsupported. Recommend evaluation by a qualified contractor or engineer for evaluation.

Approximately 3 feet of the concrete foundation has been dug out and left unsupported

Contact a qualified professional.

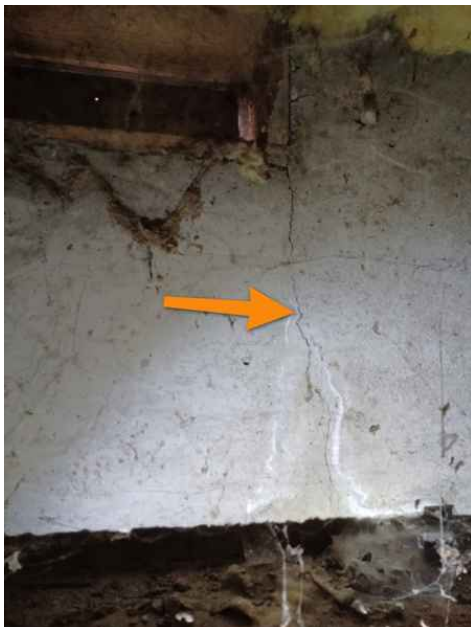
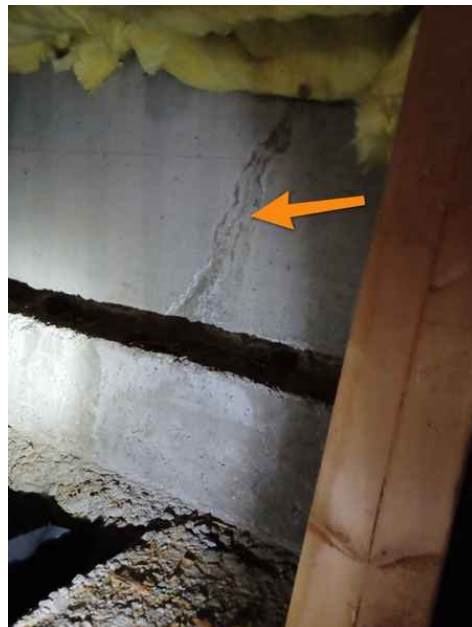
Efflorescence noted on the crawlspace surface. This is a white, powdery deposit that is consistent with moisture intrusion. This can compromise the soil's ability to support the home structure and/or lead to mold growth. Recommend a qualified contractor identify source or moisture and correct.

Efflorescence at small crack in the concrete foundation

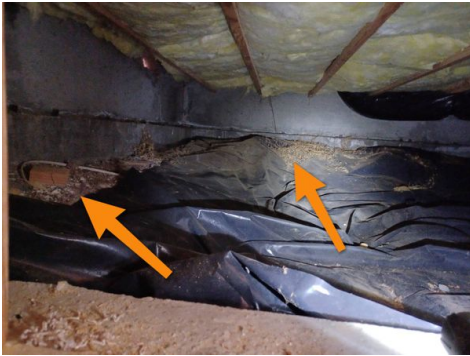
Trash, construction debris and dead vegetation are present in the crawlspace. Recommend removal as these items can attract pests.

Dead vegetation and trash

Contact a qualified professional.

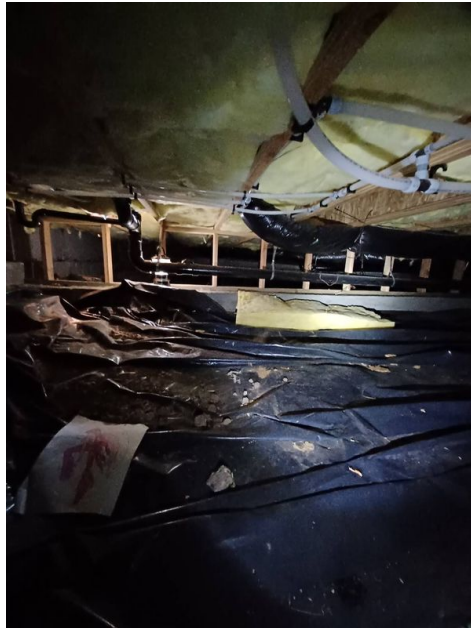
Trash

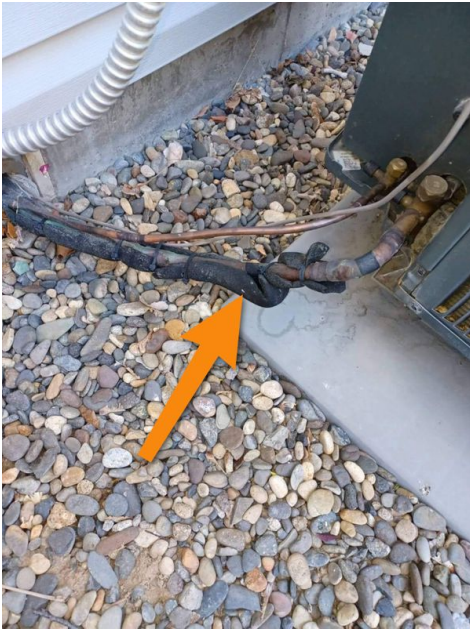
Missing or damaged insulation on refrigerant line can cause energy loss and condensation.

Incomplete insulation on refrigerant lines

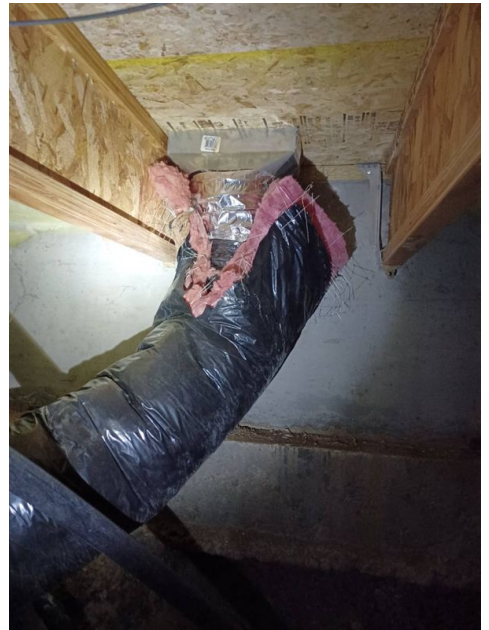
Parts of the ductwork are uninsulated, resulting in energy loss. Recommend licensed HVAC contractor insulate.

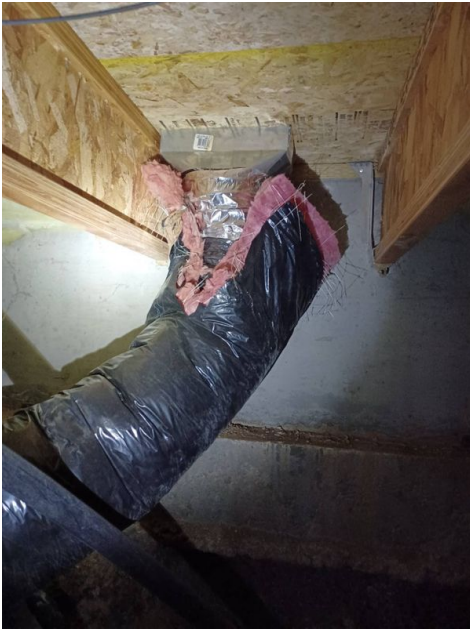
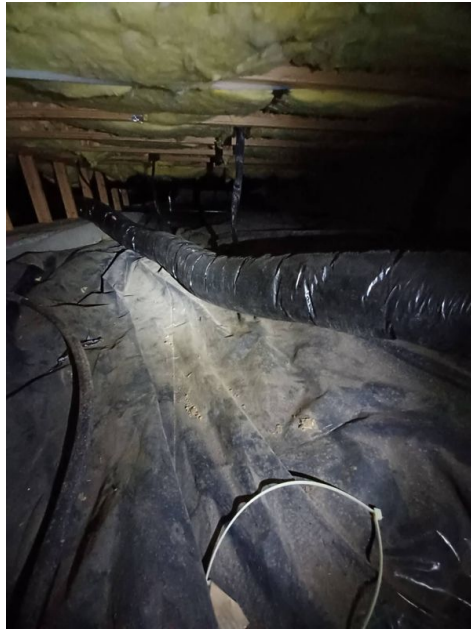
Air supply duct was damaged. Air supply duct not strapped. Recommend a qualified HVAC contractor repair.

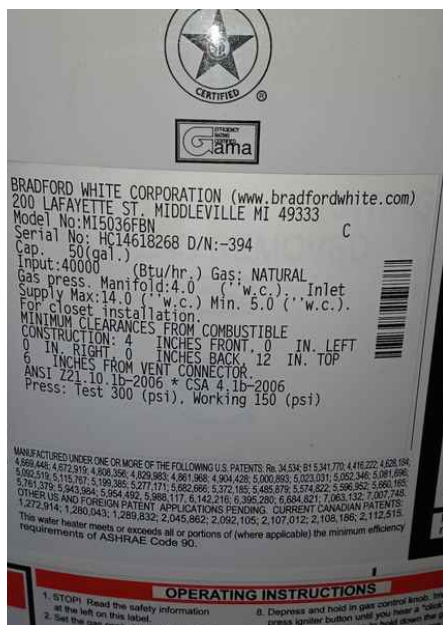
## Data Tag

### Hot Water Systems, Controls, Flues & Vents: Power Source/Type

Gas

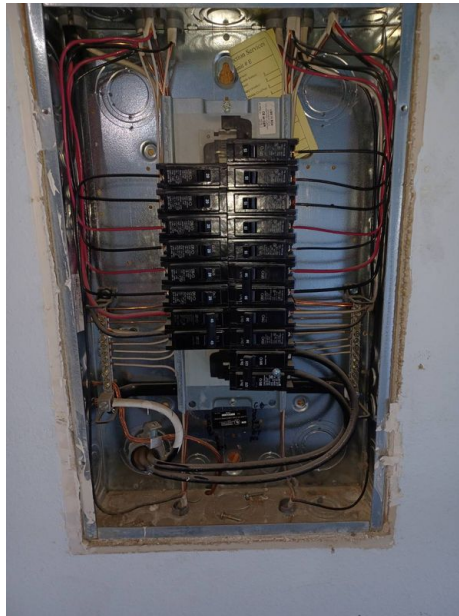
**Main & Subpanels, Service &  
Grounding, Main Overcurrent  
Device: Main Panel Location**  
Garage  
No deficiencies observed.

**Main & Subpanels, Service &  
Grounding, Main Overcurrent  
Device: Panel Capacity**  
125 AMP

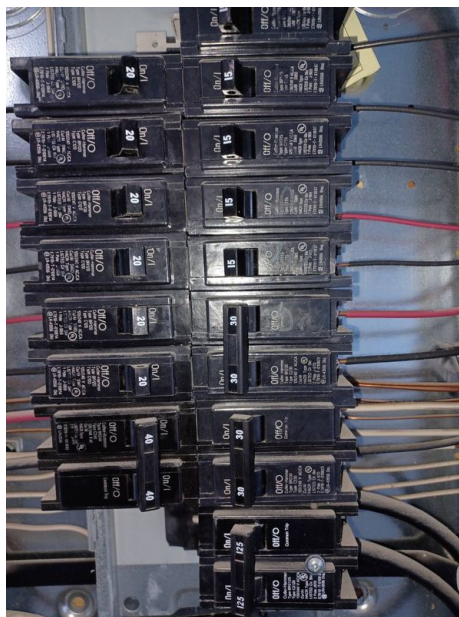
**Main & Subpanels, Service &  
Grounding, Main Overcurrent  
Device: Panel Manufacturer**  
Cutler Hammer

**Main & Subpanels, Service &  
Grounding, Main Overcurrent  
Device: Panel Type**  
Circuit Breaker

**Branch Wiring Circuits, Breakers  
& Fuses: Branch Wire 15 and 20  
AMP**  
Copper  
No deficiencies observed

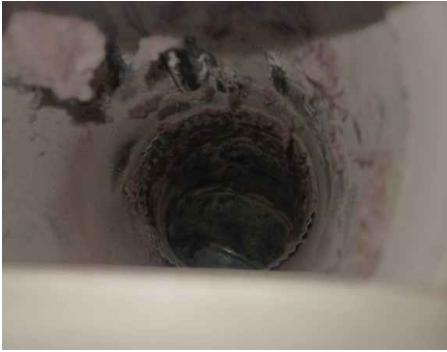
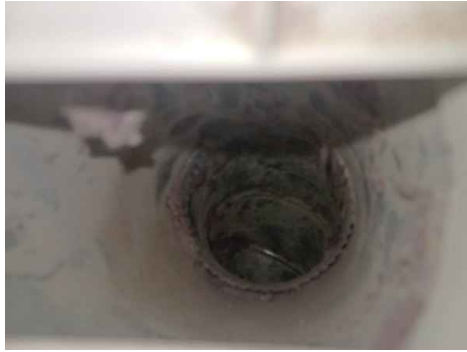
Dryer vents through a hole in the foundation on the east side of the home near the a/c condensing unit. Recommend cleaning periodically to help reduce lint build up and keep the dryer running efficiently.

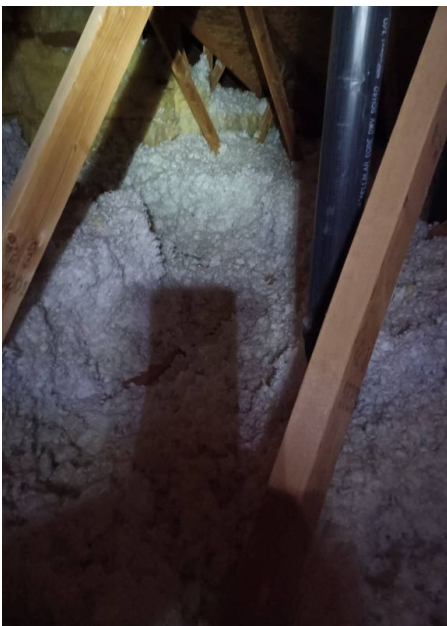
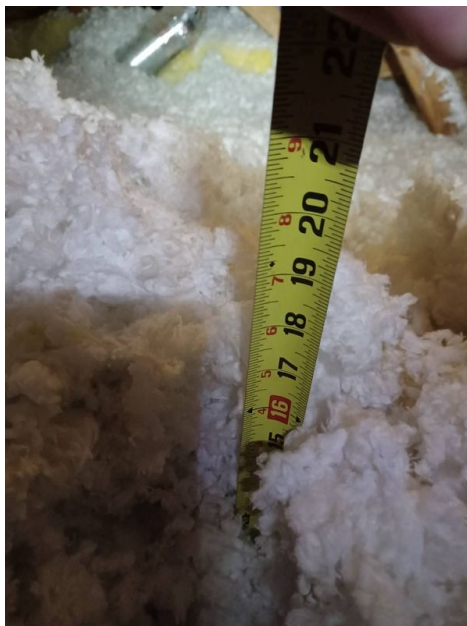
### Attic Insulation: Insulation Type

Blown

Insulation is blown-in to a level of 16-18 inches. The garage does not have insulation above it and there are a few areas where the insulation has settled.

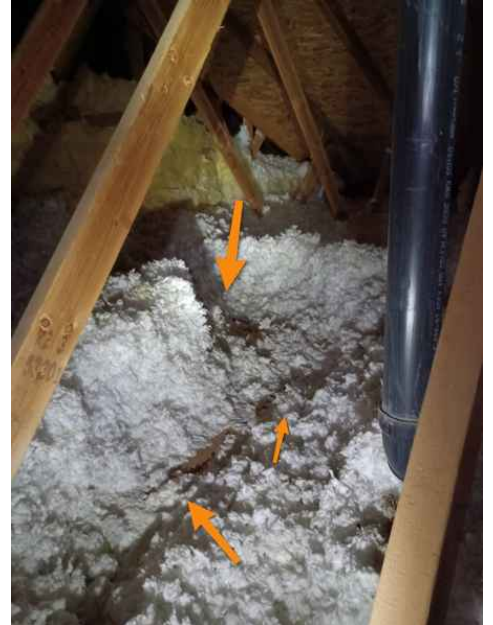
There are areas in the attic where insulation depth was inadequate. Recommend a qualified attic insulation contractor install additional insulation.

Insulation has settled or been moved in areas of the attic.

Contact a qualified insulation contractor.

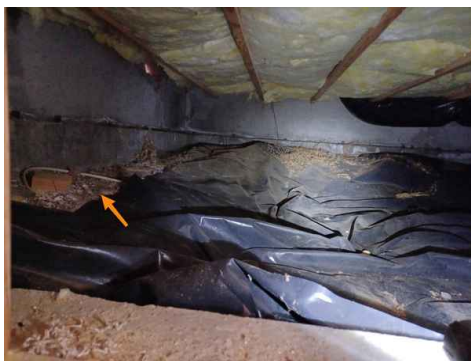
Vapor barrier is improperly installed. The vapor barrier is not fastened which has resulted in portions of the dirt in the crawlspace to be exposed. This can result in unwanted moisture. Recommend insulation contractor evaluate.

Exposed dirt

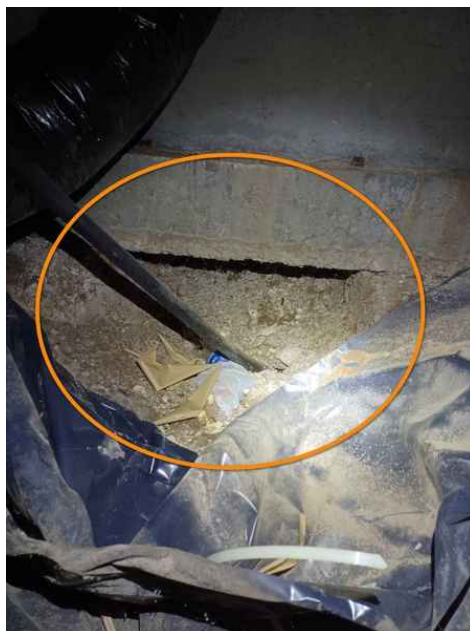
Vapor retarder pulled back exposing dirt

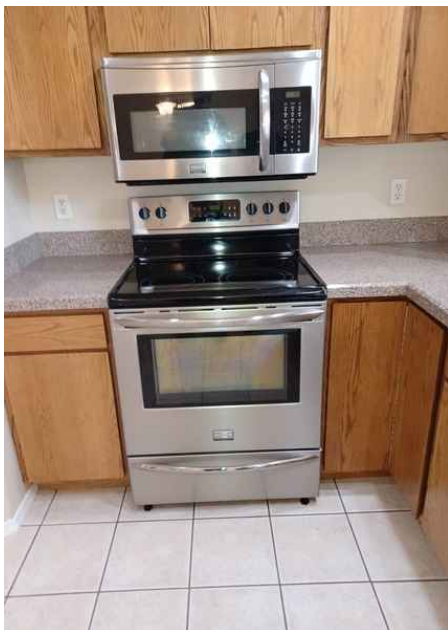
All burners and oven were operable. No cracks were present on the glass cooktop. Microwave is mounted at 14" above the cooktop which is within the recommended distance of 13"-16". Microwave exhaust fan was operable.

Range and Microwave

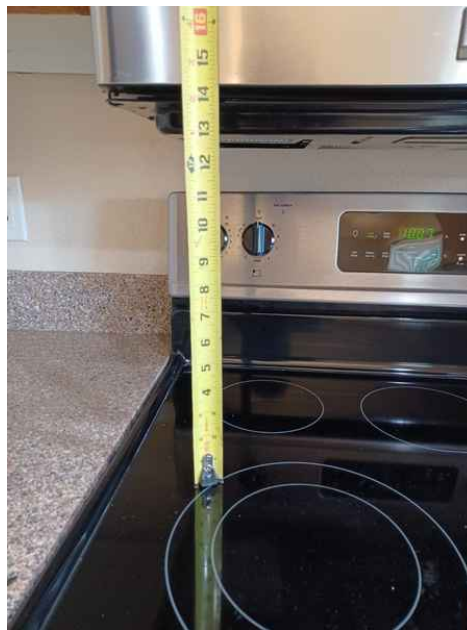
Distance of microwave to glass cooktop

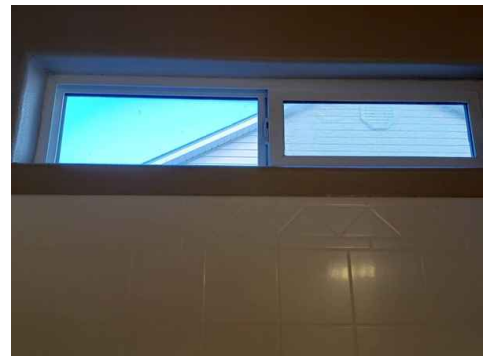
Observed small amount of condensation between the window panes in the master bathroom, master bedroom, bathroom 2, back bedroom, and kitchen which indicates a failed seal. Recommend qualified window contractor evaluate & replace.

bathroom 2 window

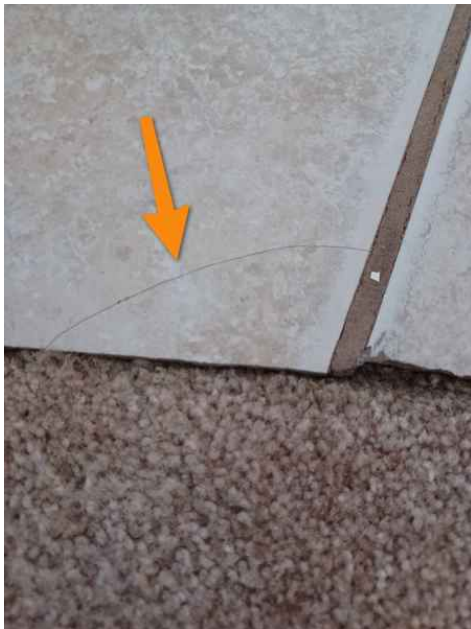
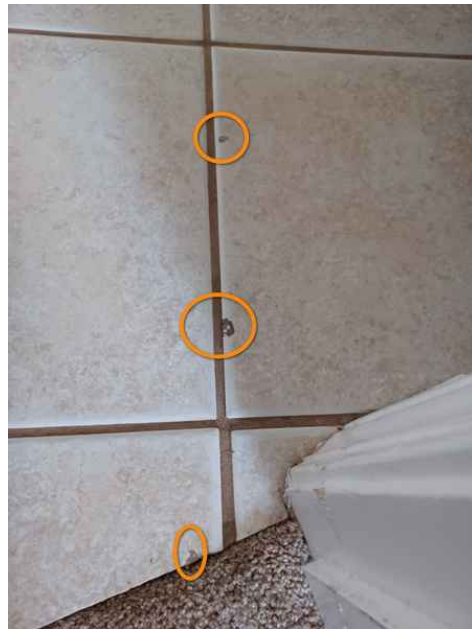
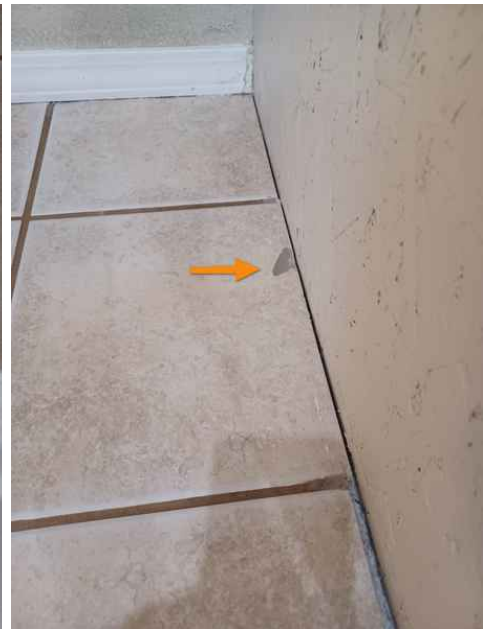
Observed hairline crack at entry to master bathroom along with some chipping of tile near vanity cabinet. Chip at refrigerator space.

Entry to master bathroom crack in the tile

chips in the tile in the master bathroom

Contact a qualified professional.

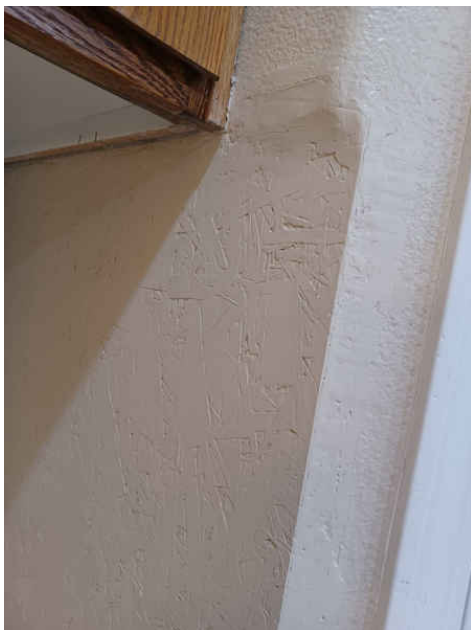
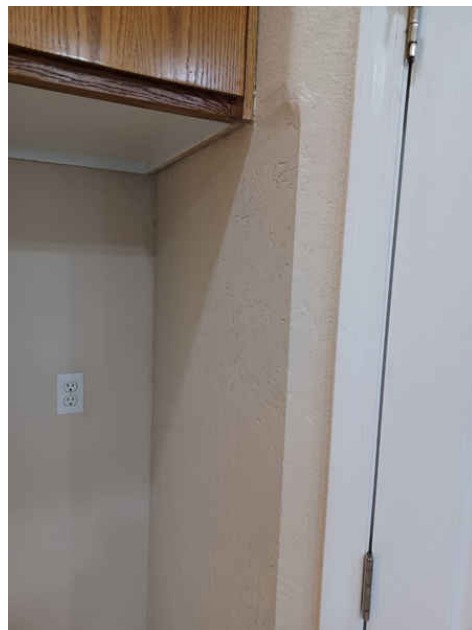
Drywall has been removed at right side of refrigerator space and painted OSB board installed.

Drywall removed and OSB installed

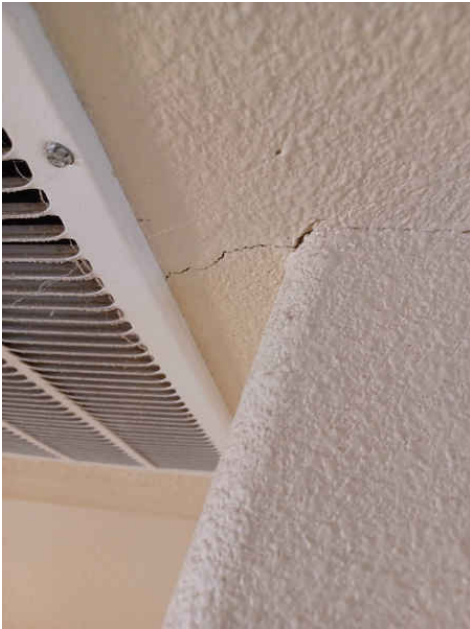
Minor damage to the ceiling was visible at the time of the inspection. Crack on the ceiling at the forced air return.

Crack in the drywall at the forced air return

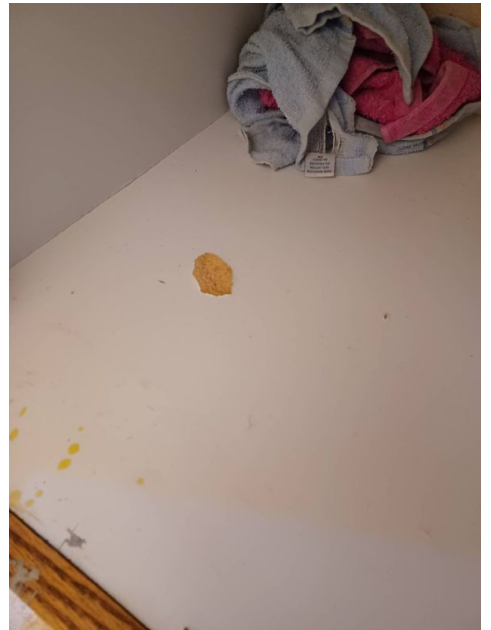
Cabinets had visible damage at time of inspection.

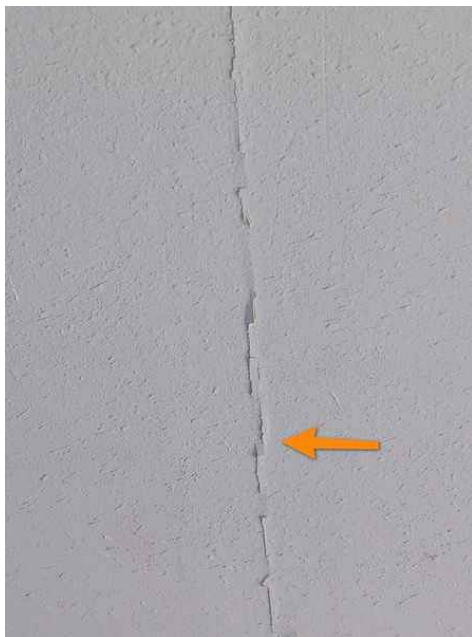
Drywall tape along a joint in the ceiling of the garage is separating from the drywall. Recommend qualified contractor evaluate and repair.

Drywall tape separating from drywall joint in ceiling

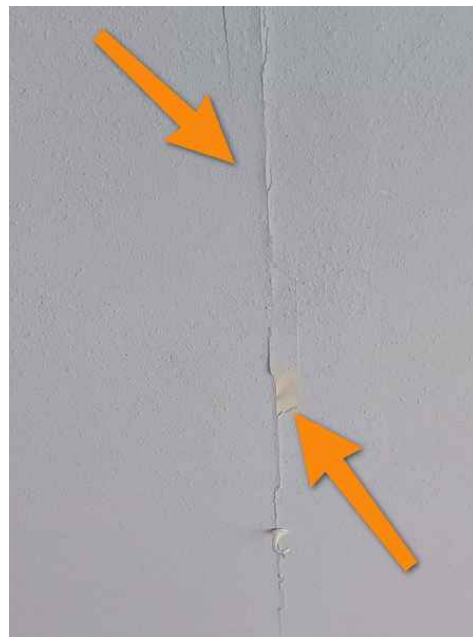
Drywall tape separating from drywall at drywall joint in ceiling

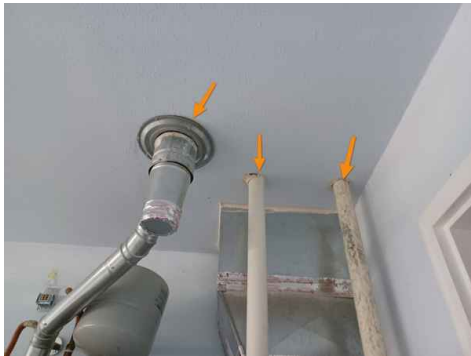
There are 3 ceiling penetrations that pass through into the attic. The two pipes that originate from the furnace unit have caulking that is cracked and the exhaust pipe from the water heater did not have

Cracked and missing caulking

Contact a qualified professional.

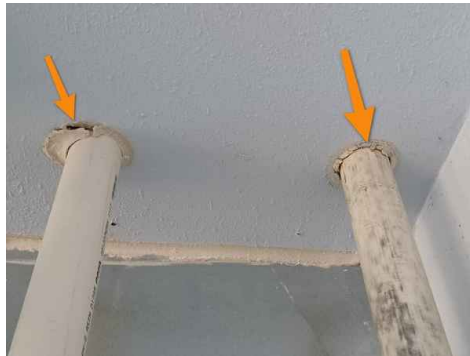
Cracked caulking
